**Kurt Mitenbuler & Associates, Inc.**

**Property Inspection location:**  
[REDACTED] Ave.  
Chicago , IL

**Inspection Date** Friday, October 31, 2008

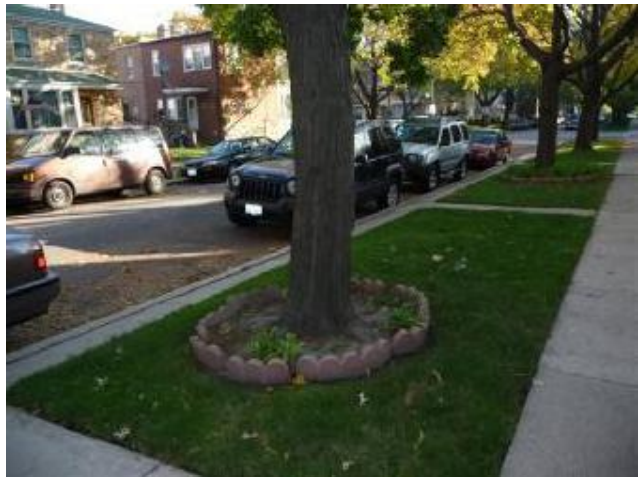
**2**

1) The tree(s) in the parkway may be putting roots into the sewer. This can cause backup into the bsmt., and it can also damage the sewer tile so that it needs expensive repairs. You should rod and videocam the sewer to determine it's condition. Annual rodding to clear roots and dirt should be done to maintain the sewer.

Trees in parkways put roots in sewers. You should rod and videoscope the sewer to determine its condition.

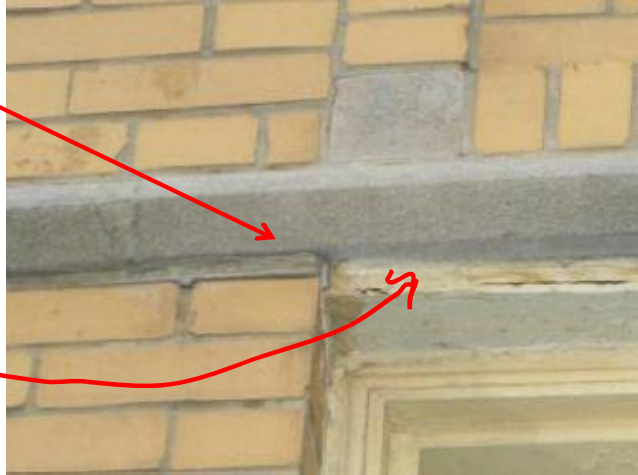
3

Several of the lintels on the front elevation are rusted, warping, and delaminating. The “repairs” thus far involve caulking the lintels. The caulking is causing moisture in the masonry to be retained in the wall where it accelerates the deterioration of the lintels. Look at the photolog, and you will see rust stains, warping, and moisture weeping out from the lintel caulking that is failing because moisture in the wall is migrating to the exterior like it should be.

The upper corners of several windows had the beginning stages of lintel deterioration. The lintel is rusting, and pushing the "tuckpointing" out.

The caulk in the window holds moisture in the wall, accelerating the deterioration.

The good part here is your building lintels not so far gone that you are going to need massive rebuilding. You are going to need lintels replaced, though. By my count, there are at least 7-10 lintels that need replacing in the next couple years. Given the way these things work, different contractors are going to recommend different lintels that could or should be replaced.

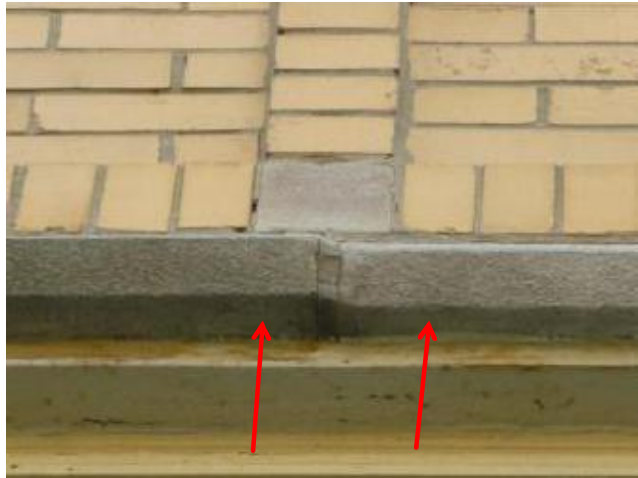
4

Dissimilar movement in the stone details over the lintels indicates lintel deterioration and resulting movement.

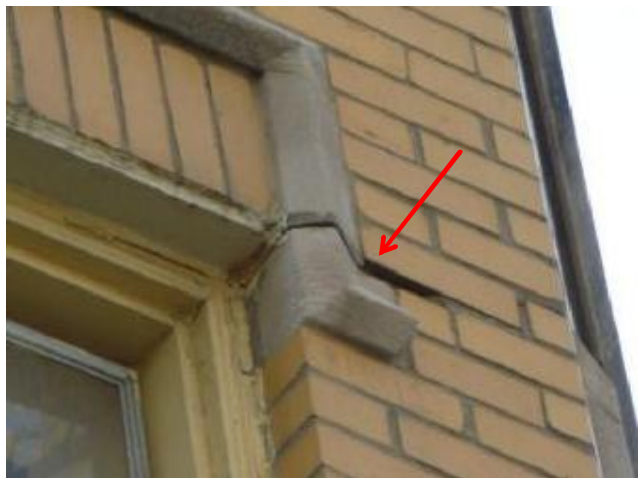
5

Mortar deterioration from recent "tuckpointing" at several of the windows

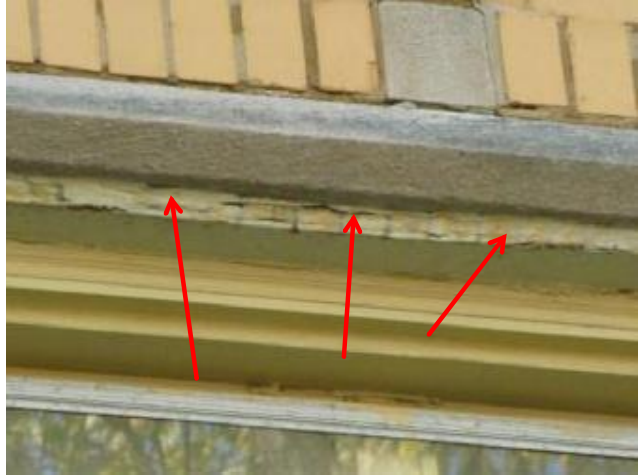
6

Caulking lintel in this manner holds moisture into the assembly and accelerates the deterioration.

Note the hair line cracks with rust stains; that's water pushing open the caulk and wicking out.

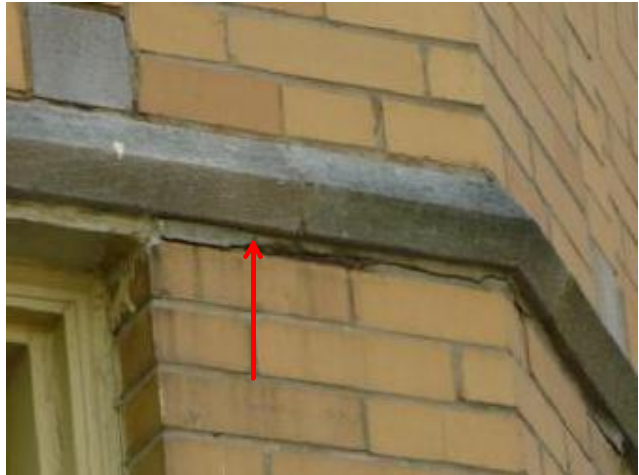
7

Similar conditons at the front bay details.

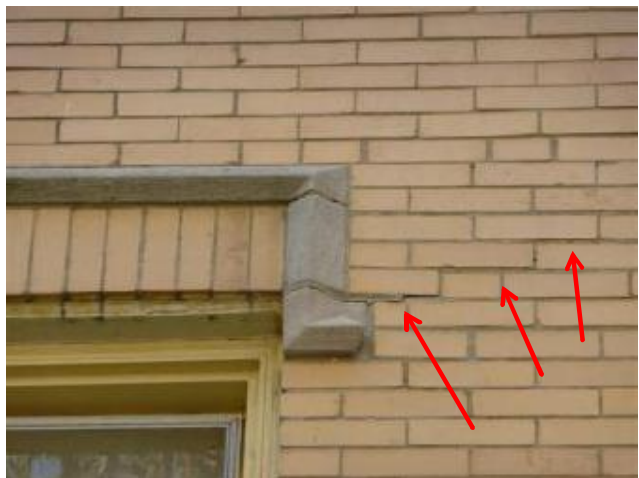
8

Misaligned stone details at another window corner.

Cracks radiating upward in stairstep pattern are the initial stages of lintel jacking and masonry damage.

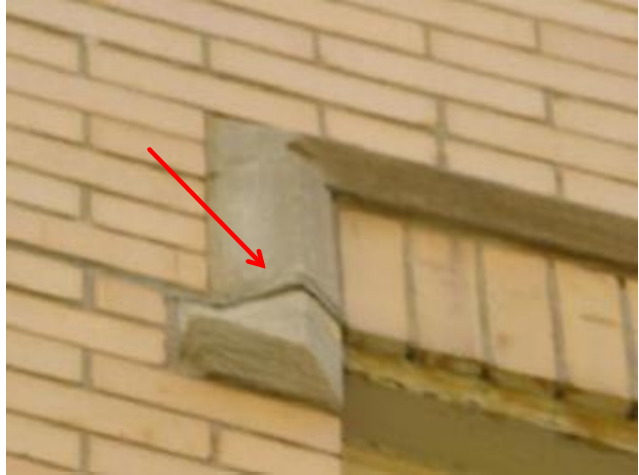
9

Close up of opposite details shows the mortar being pushed out by the deteriorated lintel.

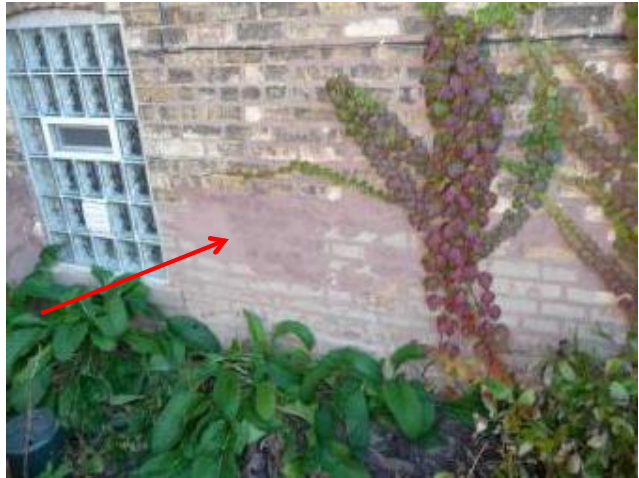
10

"plastering" is not tuckpointing. This overlay mortar will likely loosen and crumble off in the next few years, revealing additional damage underneath.

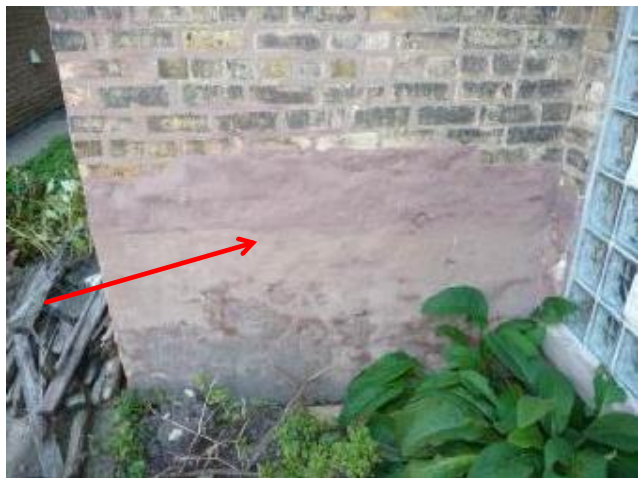
11

Where these skim coat repairs are most obvious are at the west and southwest portions of the lower wall. In these locations, the mortar has been literally smeared over the brick and colored to look like brick. Also, the garage walls lower masonry is peeling and in poor condition due to decades of improper repair.

SW corner has large areas of plastered mortar. There are loose areas indicating the material is flaking off.

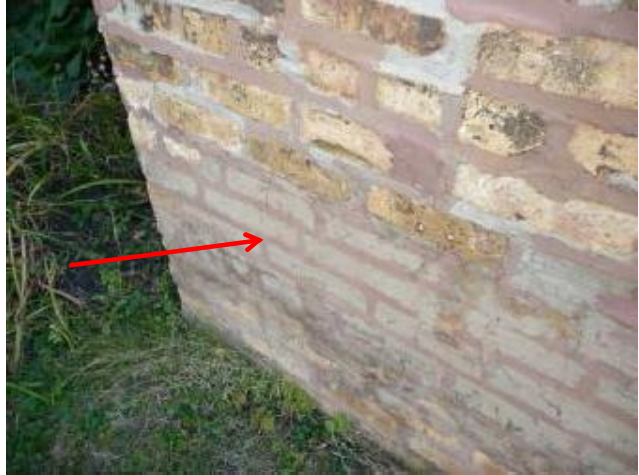
12

These bricks were literally "painted" with colored mortar.

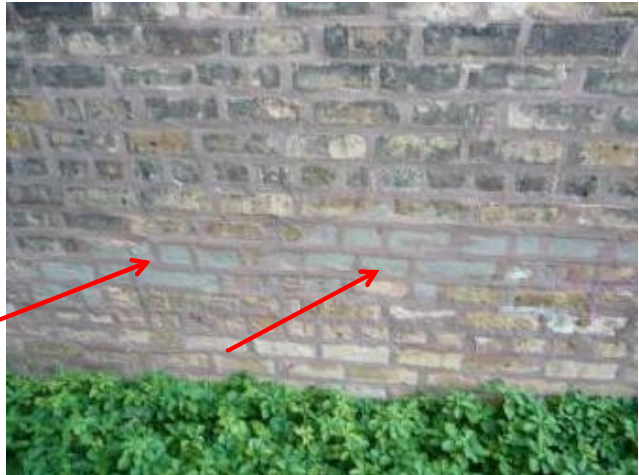
13

More of the same as previous.

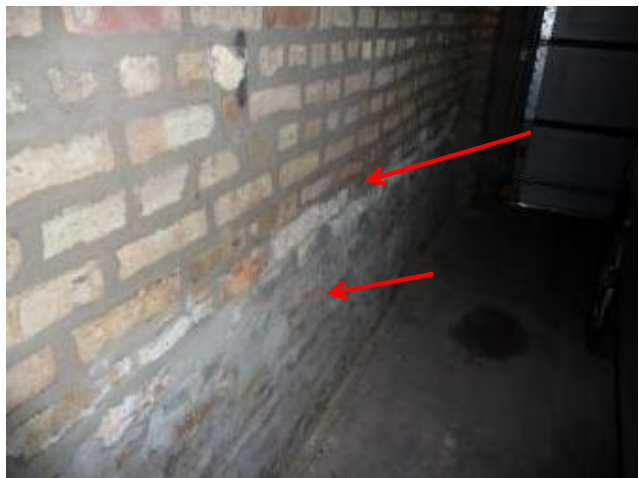
14

2) The garage sidewall brick is in various stages of deterioration. The problem is water soaking into the brick, with resulting freeze/thaw cycles causing the brick to fall apart. The repairs made thus far work "against" known materials properties / a thorough discussion of this is provided in the Sidewall section of this report.

Interior garage wall showing deterioration from moisture migration through the brick.

The garage brick has to be repaired properly, or the continuing deterioration will accelerate and likely damage the walls to the point expensive rebuilding will be necessary.

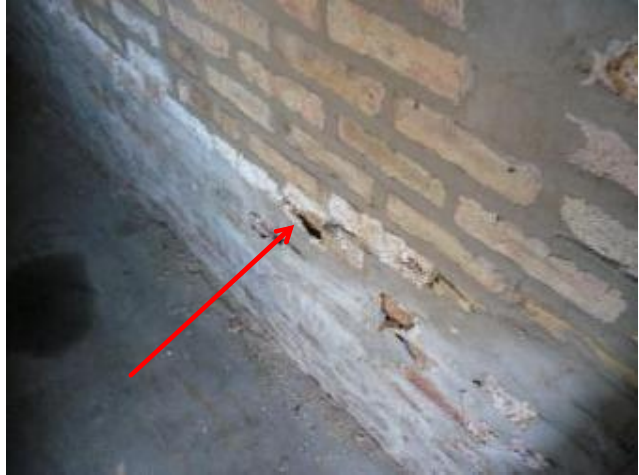
15

Garage interior plaster coat is peeling off.

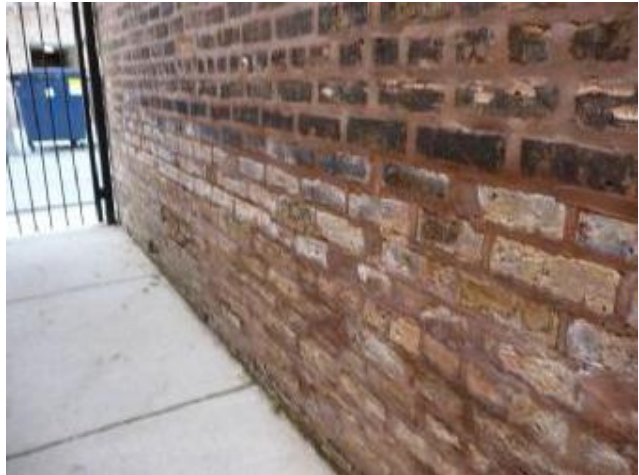
16

Garage outside wall showing moisture damaged brick.

The damage was exacerbated by the incompatible (red) mortar.

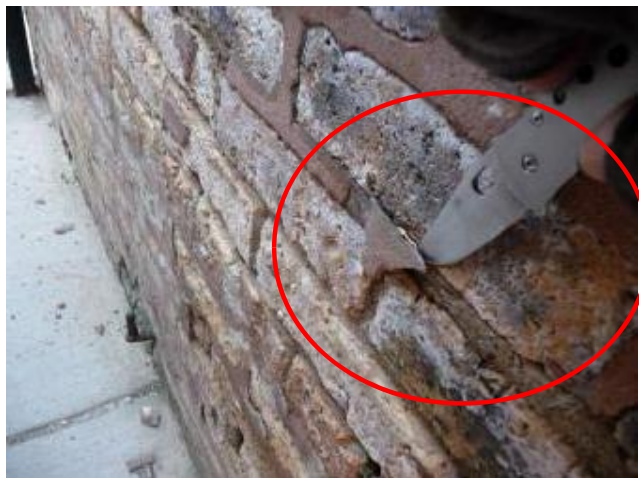
The mortar at the garage is flaking off.

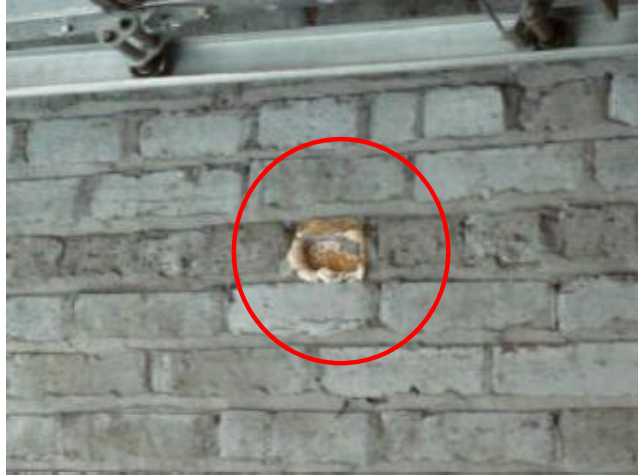
18

Bond bricks at the garage interior illustrate how the moisture is migrating through the wall.

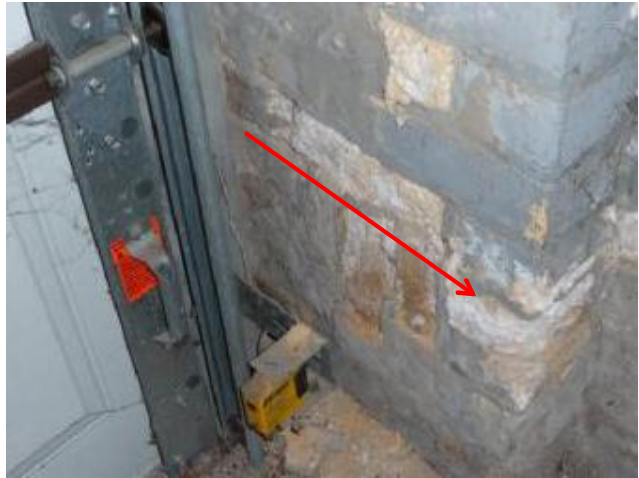
19

More moisture deteriorated brick.

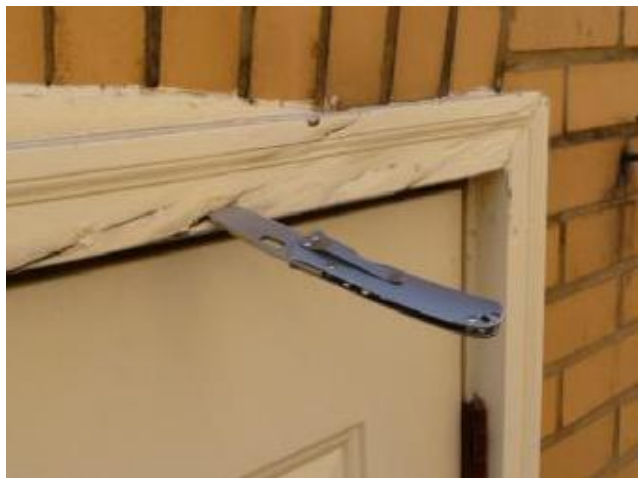
20

3) The garage service door(s) have rot in the brick molding over the doors. There should have been metal drip caps installed over the doors when they were replaced to divert water out over the trim and away from the wood.

Rotten door frame over garage service door.

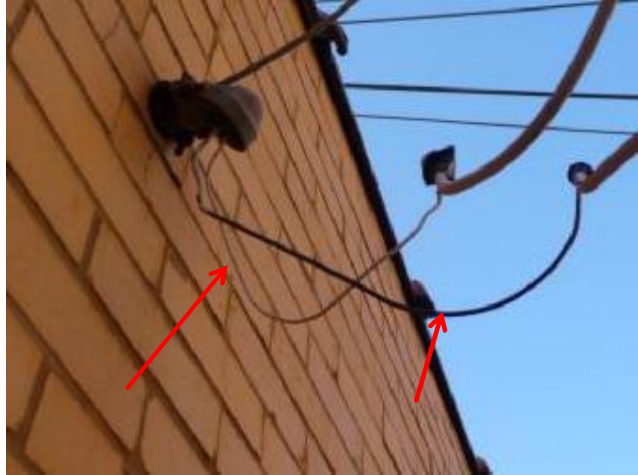
21

4) The garage overhead supply wiring isn't a material approved for use in sunlight; the UV will break down the insulation and cause it to fail, creating a dangerous condition. You should have the wiring replaced with a UV resistant type, or bury the wiring underground.

Garage service wire isn't approved for UV exposure. The garage service should be replaced with wiring approved for UV and wet locations.

Since this service is low (<10'), there is the chance for it being touched. Low overhead service wiring is a hazard.

You should consider burying the service to the garage so it is not located overhead.

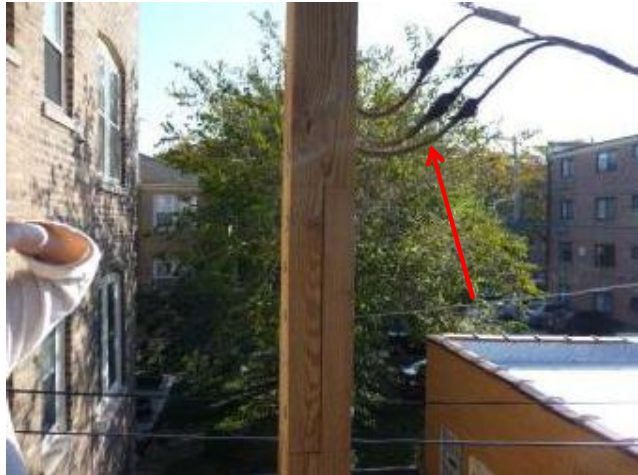
22

2) The electrical service masthead is attached to the rear deck. The service can be easily reached by any occupant navigating the stairs. This is a shock or electrocution hazard. Electrical service connections have to be installed minimum 3' outside the footprint of a porch or deck to prevent accidental contact.

The main service entrance is mounted on the rear egress porch and easily accessible by occupants. If they touch it, it could be hazardous.

The building code normally requires the service wiring to be >3' outside the footprint of the structure, or a non-conductive barrier installed to prevent accidental contact.

You should ask the power company if they approve this. They're not supposed to, but sometimes they do.

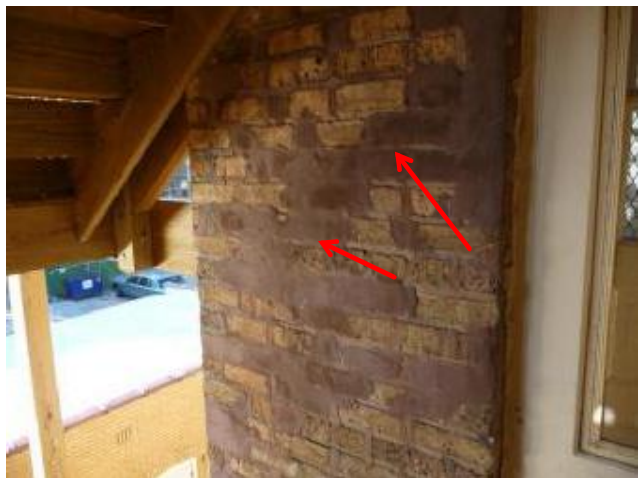
23

Spalling brick at the rear porch.

The brick is damaged and the repairs that were made are superficial. These areas might hold, and they might flake off, but either way, you should not waste money on this sort of repair. You should have the damaged brick removed and the area rebuilt properly.

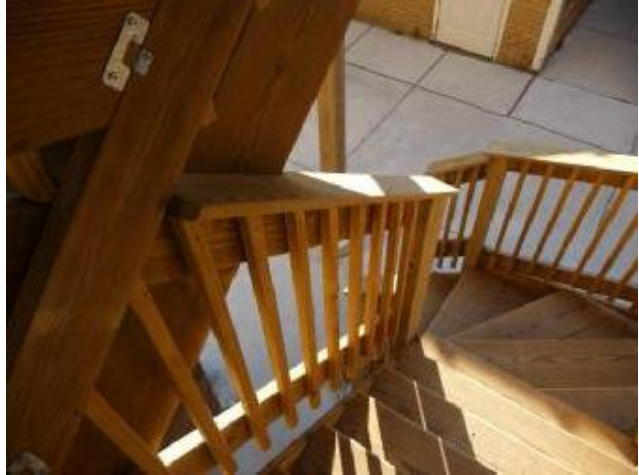
24

1) The rear egress porch stair handrails are not graspable, i.e., it is not possible to wrap ones' hand around it satisfactorily to provide for safe support when walking on the stairs. This type of 1x6 "top slab" handrail is very common, but it isn't workable. There isn't any specific requirement in the Chicago Porch and Deck codes for graspable handrails, but "graspability" is a requirement in every other code. So, whether or not the current meets code requirements is moot. You need a better handrail so occupants can navigate the stairs safely.

The rear egress porch handrails are not graspable.

There should be a graspable handrail not less than 34" nor more than 38" above the stair nosing.

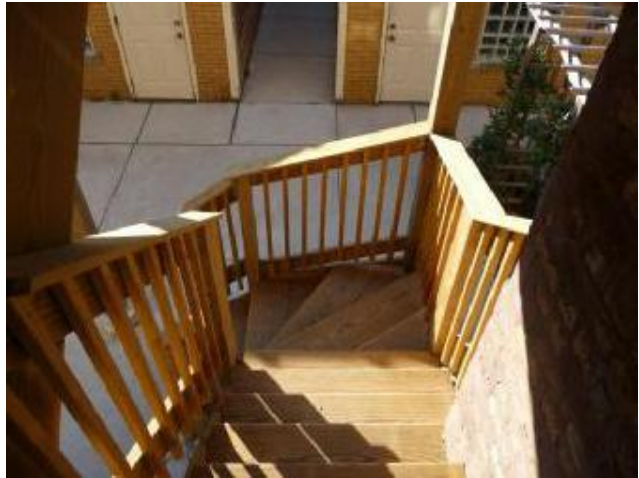
25

How this is accomplished is open to a lot of discussion, because in some areas there isn't adequate space to install standard handrails. In other locations, placing a graspable handrail on top of the current slab would make it much too high to use effectively.

The stair is narrow, so installing safe handrails will constrict the passage.

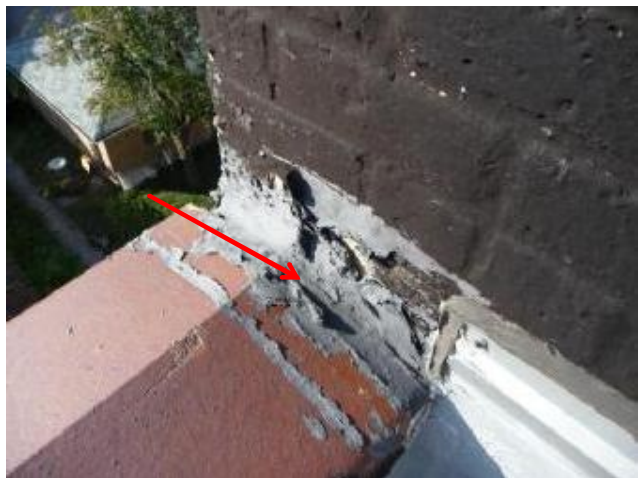
26

2) The coping stones on top of the sidewalls have gaps and openings that can leak water into the sidewall parapets. All the coping stones should have the joints sealed with a good quality caulk that doesn't open up like the roofing cement repairs that are currently in place.

Wall coping tile joints are not sealed where they adjoin the cornice parapet.

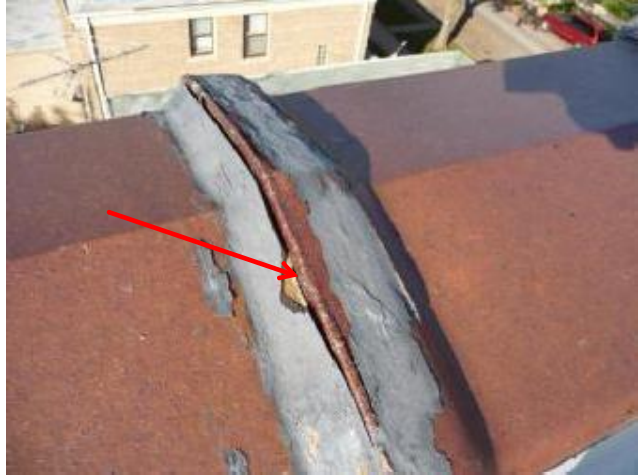
27

Nearly every coping tile joint is open like this. Water can leak into the parapet, and damage it from freeze thaw cycles.

The parapets on this building are in satisfactory condition. You want to keep them that way.

While this is a problem, it is easily solved by taking out existing black sealant and replacing it with modern caulks.

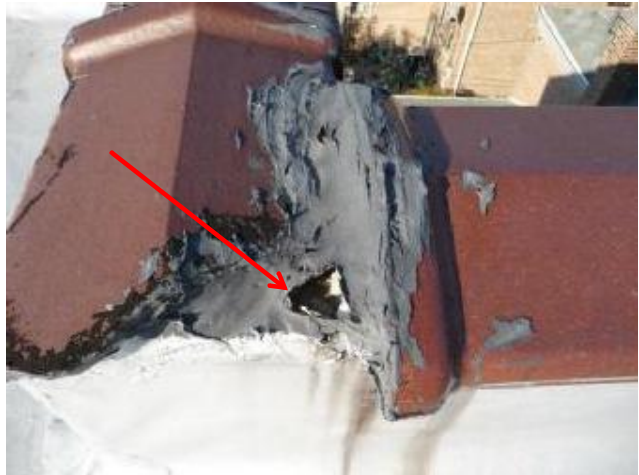
28

More of the same. All these open gaps have to be repaired.

The repair should include removing damaged tiles and replacing them with new materials.

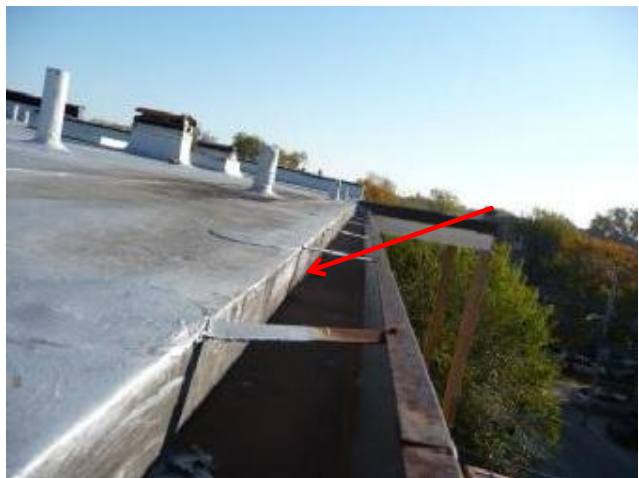
29

Wrapping the membrane down into the gutter is extremely common, but not recognized by the roofing industry or manufacturers associations as an effective or desirable method. The membrane doesn't weld satisfactorily to the aluminum, and gaps can open up that can leak during ice dam conditions. If this isn't a problem, I don't think this is a critical defect, but it is something that you should be aware of.

The rear eave gutter detail is technically wrong, but common. You may have to periodically reseal the eave if the weld to the gutter fails.

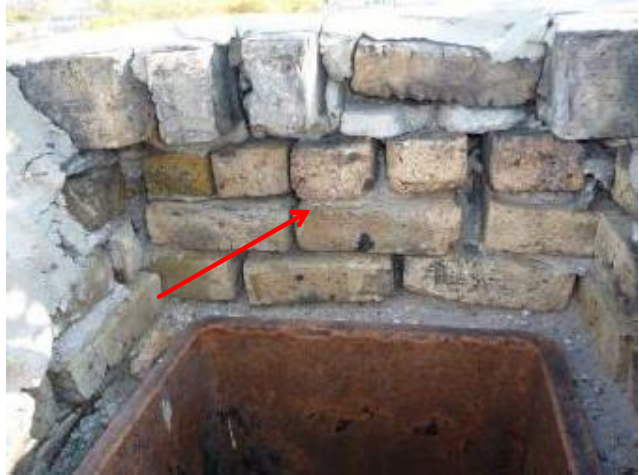
30

3) The brick chimney (for the boiler and water heating equipment) is badly deteriorated on the interior of the crown. Bricks are so loose they could tumble down the chimney flue, causing blockage that could cause combustion gas to back into the building. The bricks should be mortared placed. While a serious condition, it is an easily accomplished repair.

The main chimney interior is falling apart.  
The chimney crown interior should be rebuilt, and a rain cap installed to prevent future damage.

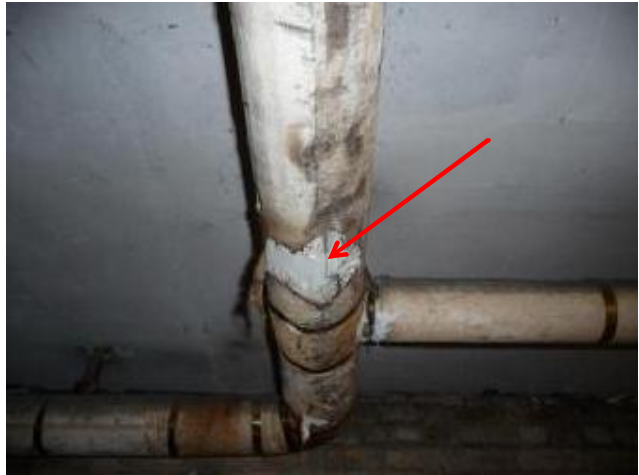
31

1) There is asbestos on the heating pipes in the bsmt., and possibly in the walls & ceilings of the upper floors. There are several damaged end caps or open areas where the asbestos is exposed. Current EPA recommendations for asbestos is to leave it in place and encapsulate it if the asbestos is undamaged and tight to the pipes. If it is damaged, the material should be removed. This material looks like it could be encapsulated satisfactorily, but there could be contractors that would disagree with me and recommend removal.

Asbestos insulation in the bsmt. has damaged end caps and joints. The material should be encapsulated and removed.

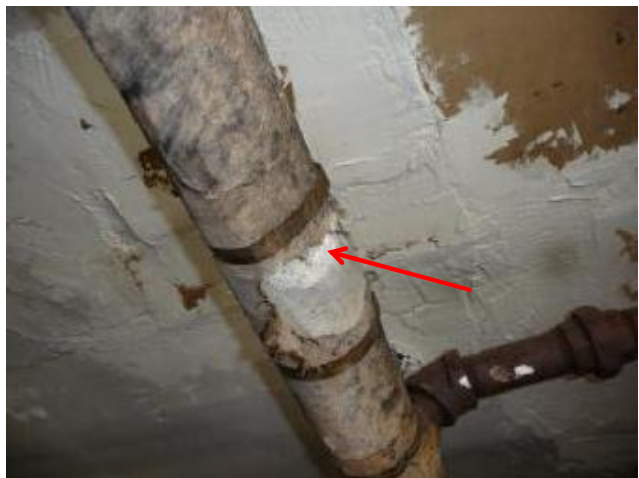
32

More asbestos open end caps.

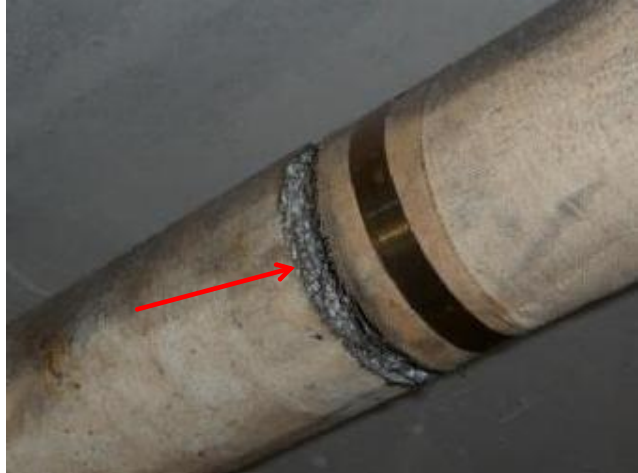
33

More open ends.

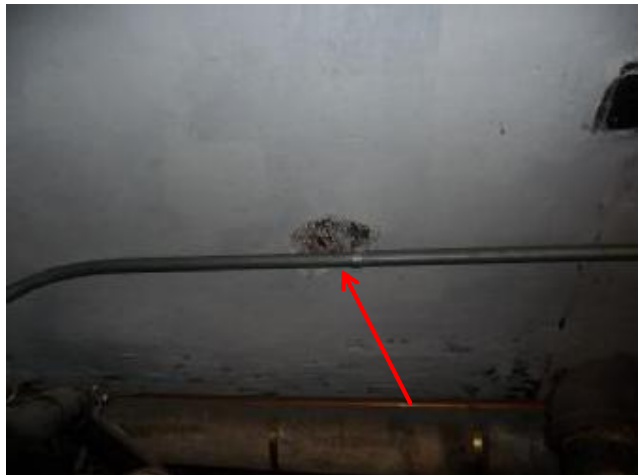
34

The bsmt. ceiling has several small holes in the plaster. These holes can allow a fire in the bsmt. to engage into the upper floors, creating a hazard. Multiple family building codes all state that there should be an unbroken fire separation of plaster or drywall on the bsmt. ceiling.

You should have a repairman seal all the bsmt. ceiling holes with plaster or drywall. This is a relatively simple and inexpensive repair, but one that you should have done.

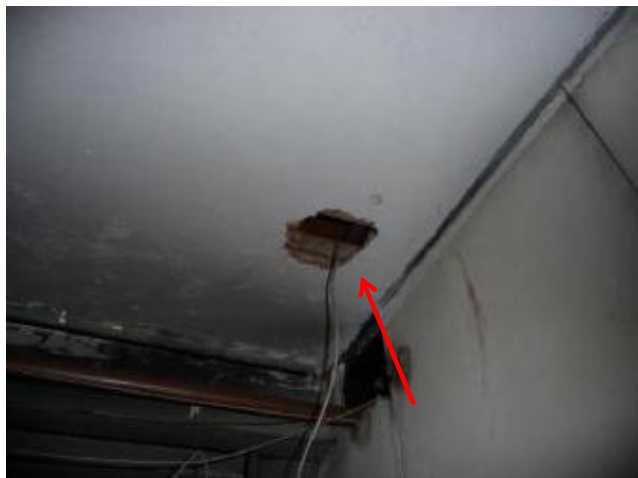
35

Same as previous, this time with wiring running through to an upper floor. This will mean some electrical repairs and alterations.

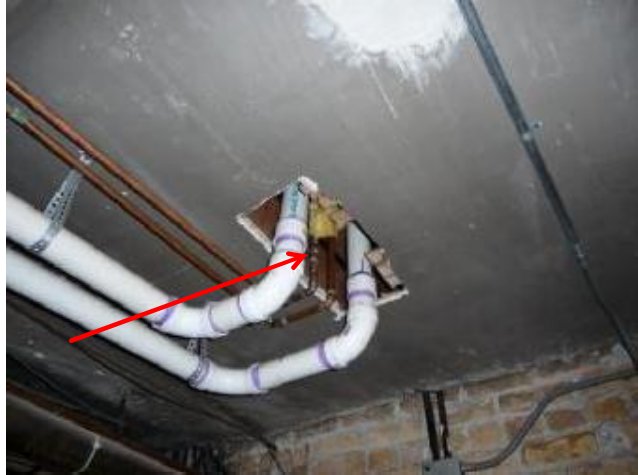
36

More of the same, this time with plumbing.

Installers are supposed to closer up the openings with plaster or drywall. It doesn't have to be pretty, but it has to be there.

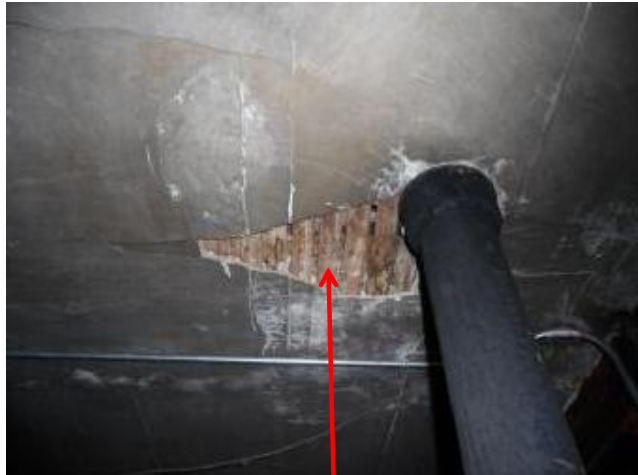
37

More of the same, this time with wood lath plaster.

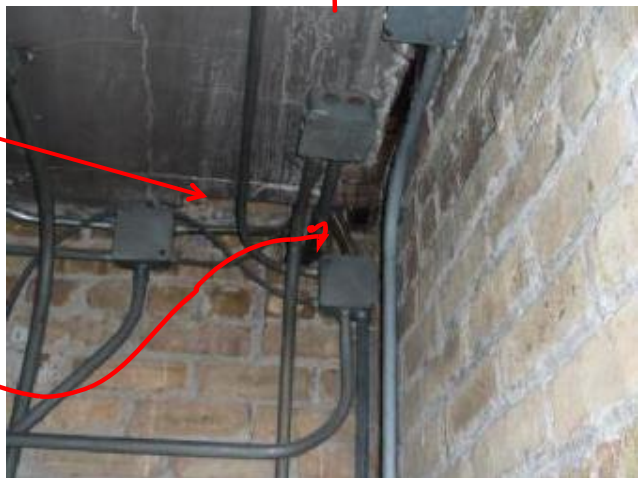
38

Bsmt. wiring over the electrical panels has a smallish tangle of AC cable. This material isn't normally approved for use in lengths >6', so this sort of application usually means portions of the installations may have had non-professional installers.

Also, there is rag wrap range cord in this corner; this material has never been approved for use in Chicago in this manner.

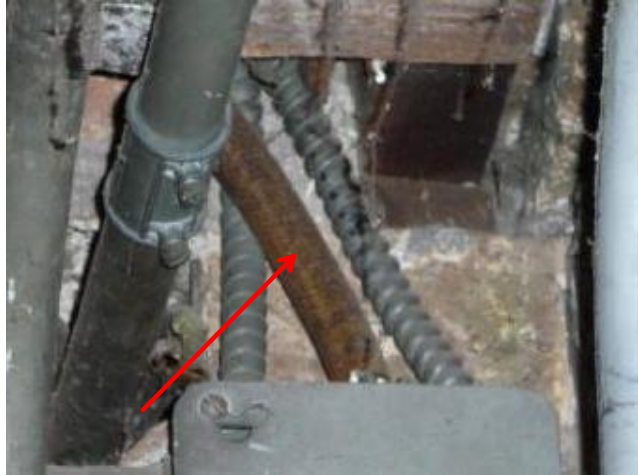
39

Range cord in a close-up

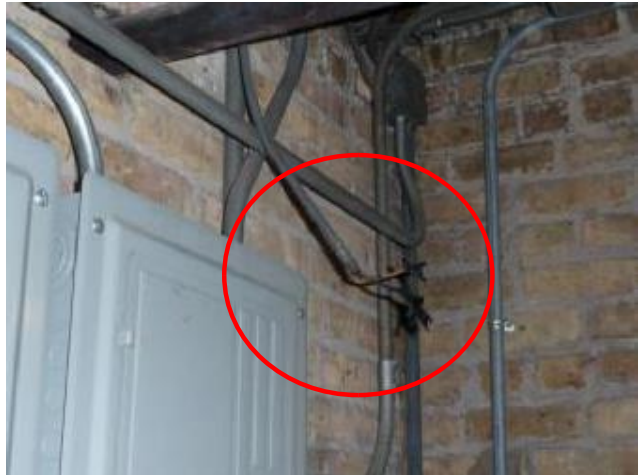
40

3) There is one strand of loose open wire above the electrical service equipment. This wire should be removed or enclosed in a junction box.

Loose wiring over the electrical panels.

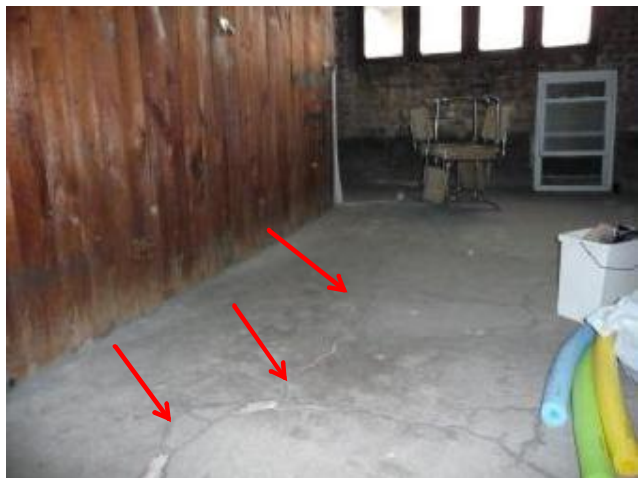
41

3) The bsmt. floor is heaved up in several locations. This is most often caused by sewer back up in the City infrastructure. The sewer backs up, water leaks out of the old clay sewer tiles, and the resulting saturation and pressure in the soil beneath the floor causes the floor to heave up.

The bsmt. floor is heaved up and cracked.

This can often mean sewer backup.

There is no repair for this other than keeping the sewer rodded out and cleaned periodically. You should have the sewer rodded annually to keep it clear.

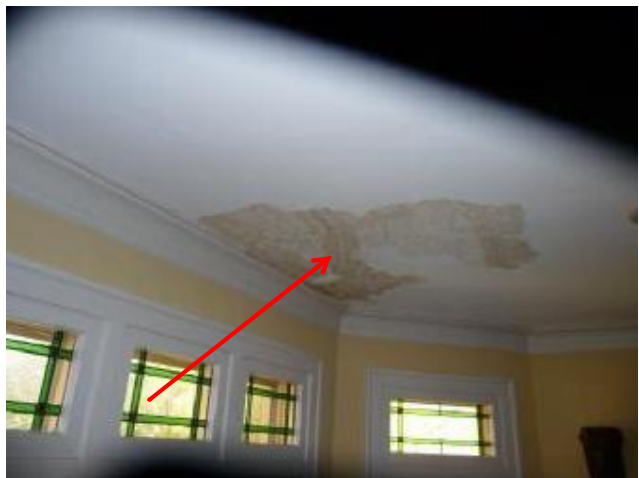
44

3) There are leaks in some of the radiator valves or vents in the building. The 2nd fl. east unit front LR ceilings and one of the BR ceilings is water stained, apparently from leaks in the radiators from above. Since I didn't have access to all of the units on the day of my inspection, I am not able to determine the specific problem(s) that are causing the leaks. This problem is something that should be able to be corrected when the radiator vent balancing and radiator repairs is occurring.

Water stain at ceiling of 2E, most likely due to leaking radiator valves, or other problem with the radiator.

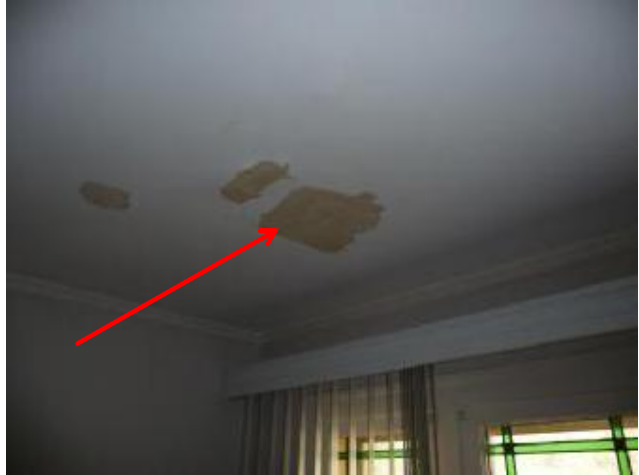
45

Another area of water damaged ceiling at 2E, most likely caused by the radiator at the floor above it.

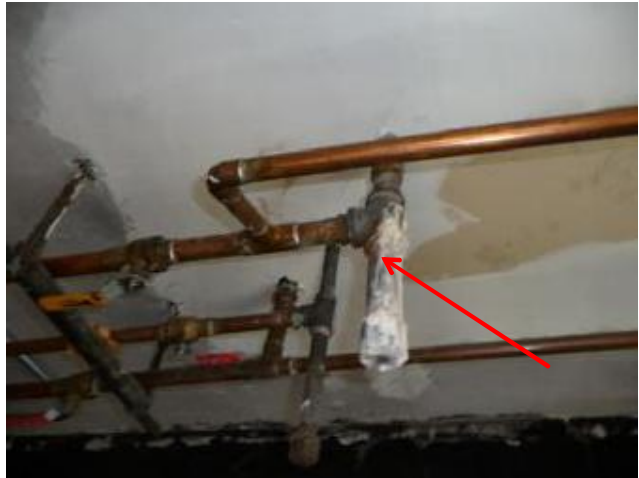
46

1) There is still old original galvanized pipe in the building. The basement laterals have all been replaced, but the original supply risers remain in place. There is at least one active leak in some of the visible piping in the bsmt. If there is one visible leak, there are probably others about to leak where I can't see them.

Old galvanized plumbing has a limited lifespan of approximately 60-80 years in Chicago depending on a wide range of variables. What this means is the pipe supply risers are due for replacement. This is a disruptive and expensive item as it requires opening walls and ceilings to access the pipes for replacement. You need to establish a budget for pipe replacement in the near future. If there are pipes that are so old that they burst and leak, it could cause flooding in the property resulting in major damage and expense. Plan on replacing the pipes.

Leaking galvanized riser connection at the bsmt. ceiling penetration.

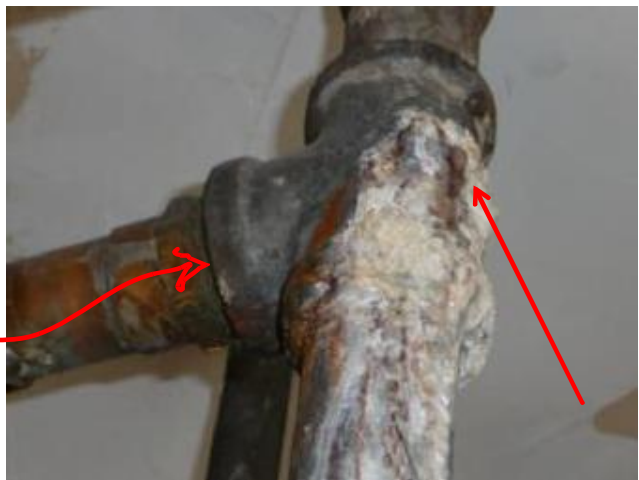
47

Close up of leaking galvanized fitting.

There is no dilectric fitting at this copper to galvanized joint.

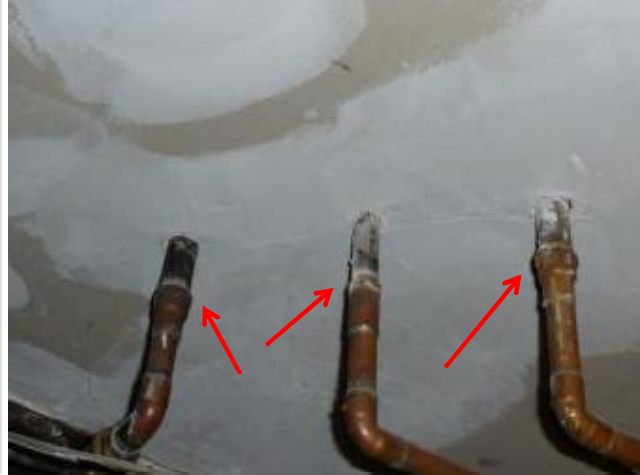
48

2) The new copper pipe connects to the older galvanized directly without benefit if a dilectric union. These unions isolate the dissimilar metals of the two pipes to prevent galvanic reaction and accelerated deterioration of the pipe. You should have dilectric unions installed between the copper and galvanized pipe.

None of the copper to galvanized connections used dielectric fittings to isolate the dissimilar metals.

The lack of dielectric fittings can lead to accelerated deterioration of the pipe from galvanic reaction. Dielectric fittings are required by all the building and plumbing codes.

When you repair the other plumbing, you should make sure that all the copper to galvanized fittings have dielectric connectors.

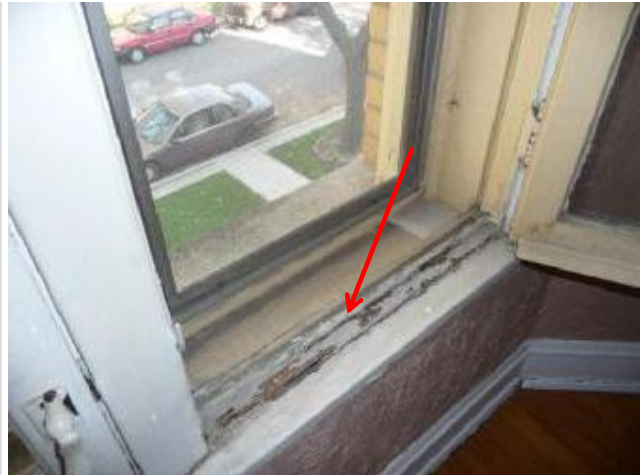
49

1) The windows are a major problem. They are contributing to the overall heat loss/cold conditions already noted in the Heating section of this report. You should replace the windows. This is an expensive process, and costs will be all over the map depending on a wide array of variables. You need to talk to several window replacement companies to begin getting an approximate estimate of what window replacement will cost.

Windows at the front bay were loose, drafty, peeling paint, and generally inefficient.

You should replace the windows with energy efficient units.

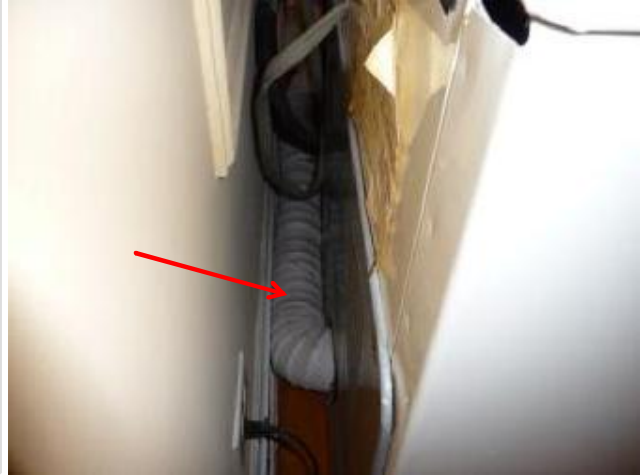
51

- 4) The laundry dryer discharge at the 2nd fl. west apt. is plastic. These plastic ducts have been cited by the CPSC and several other safety organizations as a source for home fires. You should change out the plastic duct and replace it with a smooth walled metal duct.

The laundry utilized a plastic dryer duct. The CPSC has found these plastic ducts to be the source for many house fires.

Replace the plastic ducting with smooth walled metallic ducting.

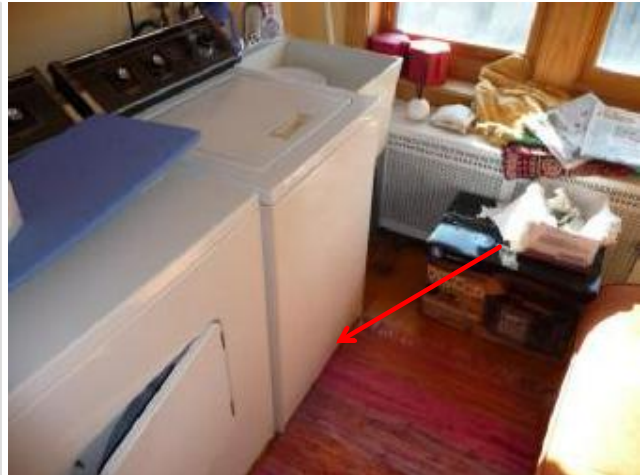
52

- 3) The laundry equipment in the 2nd fl. west unit lacks a pan under the washer to collect an leaks that occur. You should install pans under any laundry equipment in the building and connect them to a drain.

There's no pan under the washer. If the washer leaks, it will flood the apt. and floors below.

Install a redundant drain pan under the washer and direct it to a plumbing drain.
