Kurt Mitenbuler & Associates, Inc.

Property Inspection location:

Inspection Date Monday, October 1, 2007

Photolog of Major Concerns

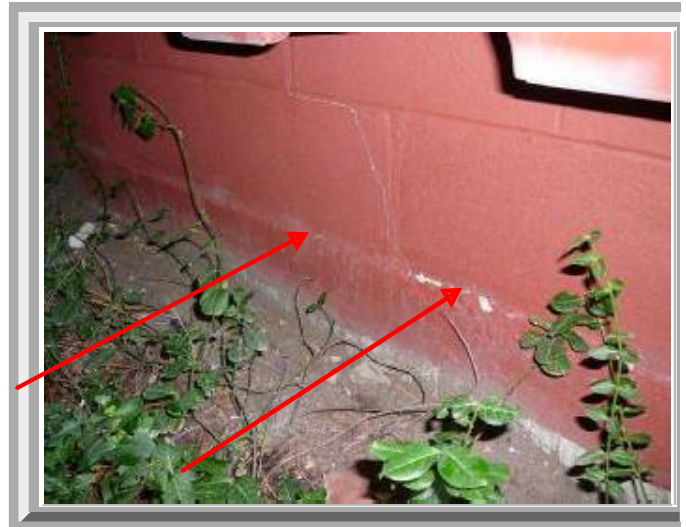
1

No through wall flashing @ the south foundation; there should be flashing, wicks, & weeps all along this joint.....

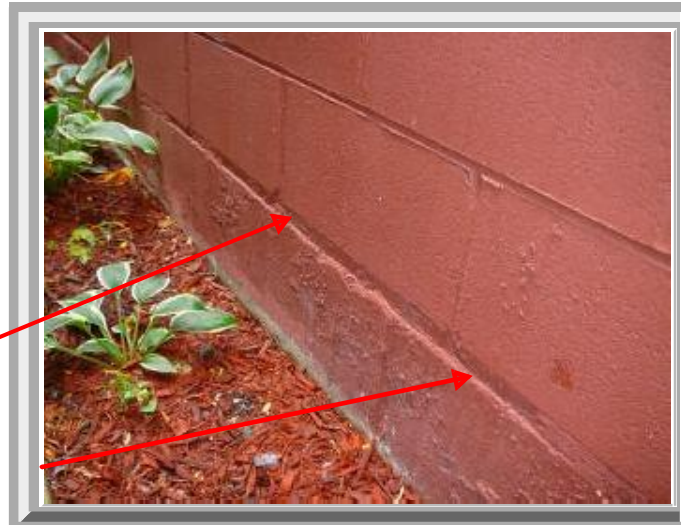
2

More of same along north north wall...

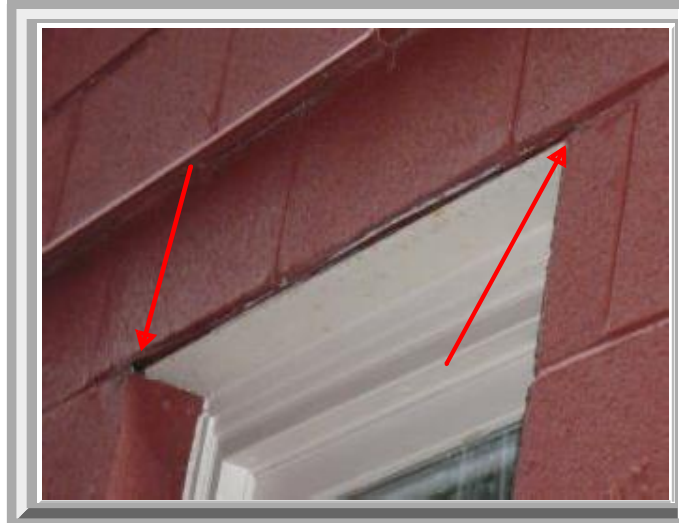
4
Flashing over a window, but no weeps or wicks.

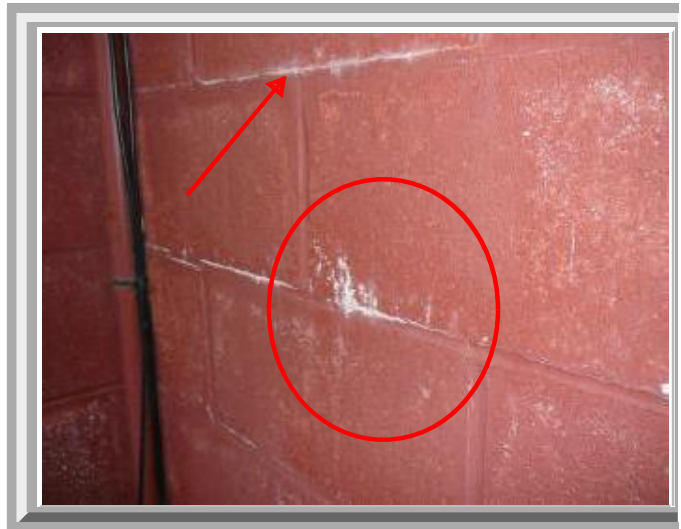
5
White stains are evidence of water in the block migrating back to the exterior.

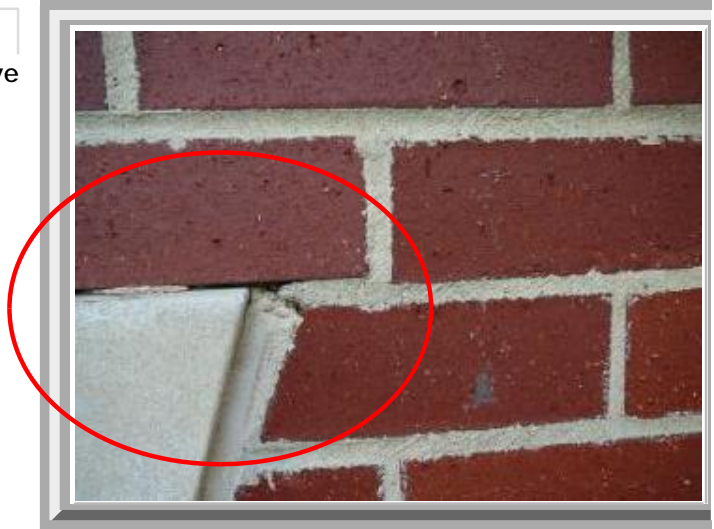
6

Typical gaps over the east/front elevation decorative elements.....

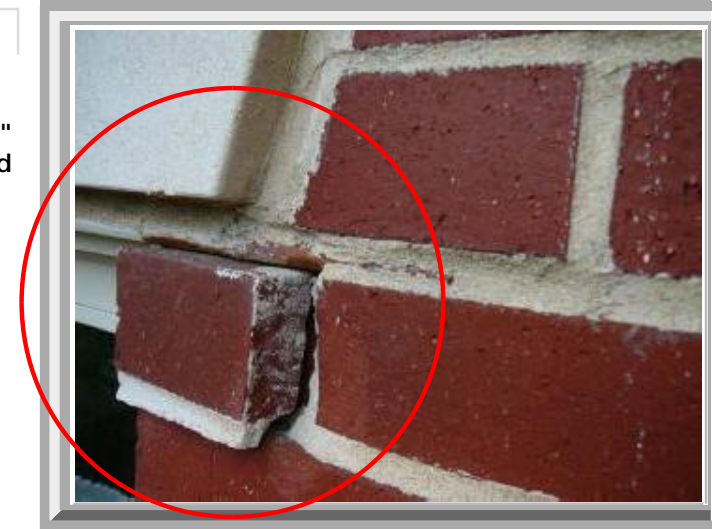
7

3rd fl. north balcony slider.

I have no idea why this brick would be "pushed out" like this, but it would be the sort of thing that would happen

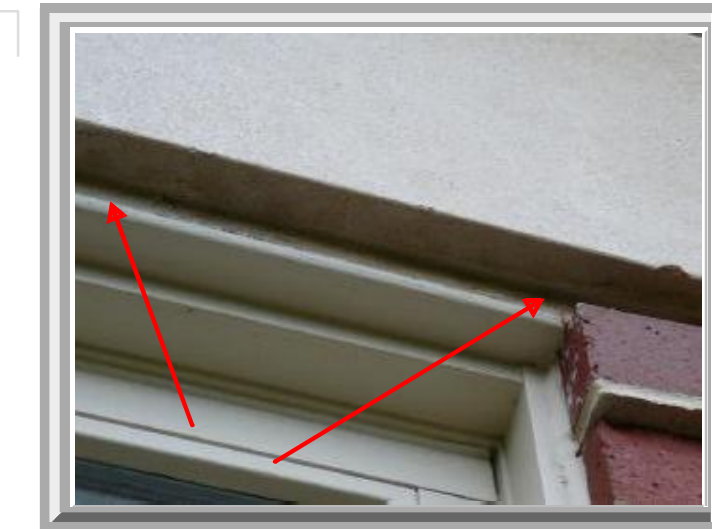
8

No flashing over one of the east/front elevation sliding doors; this is the 3rd fl. north door.

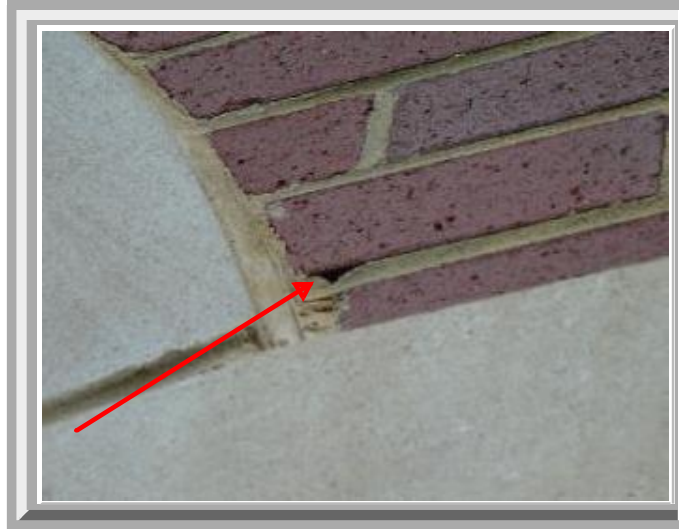
9

More gaps in the decorative element detailing.

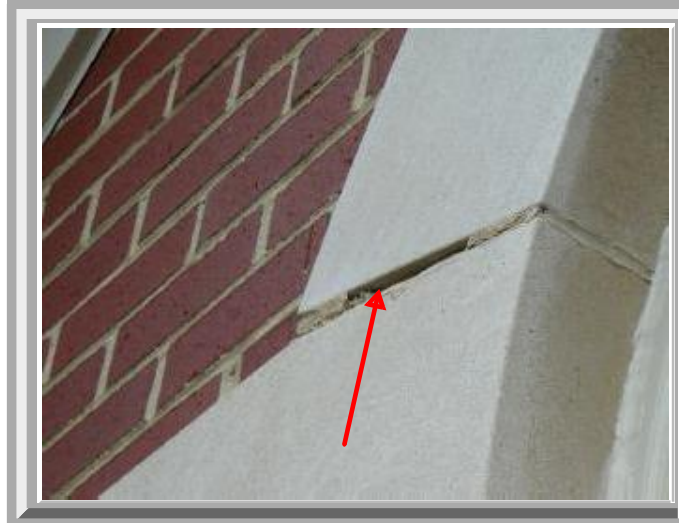
10

Gaps in arch over 3rd fl. windows; water can enter these gaps.

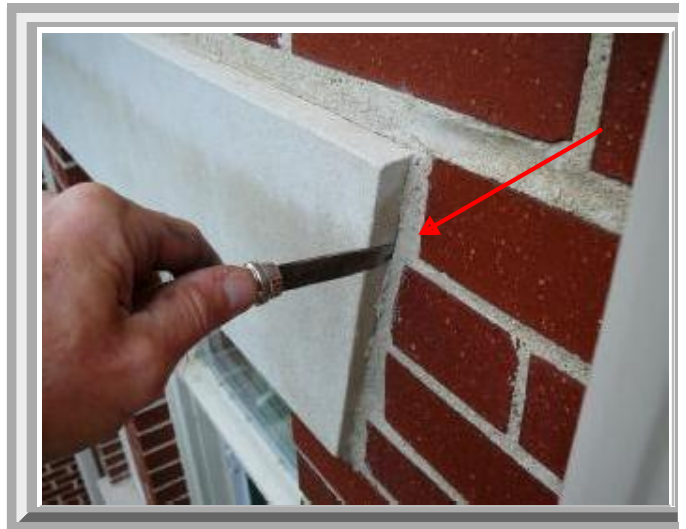
11

If I can stick my dull knife blade into cracks in the masonry, water can enter it in volume.

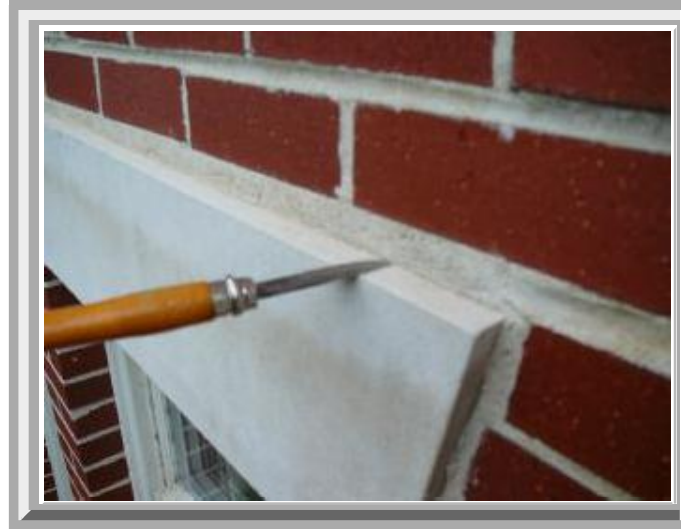
12

More similar cracks over the east/front wall decorative lintels.

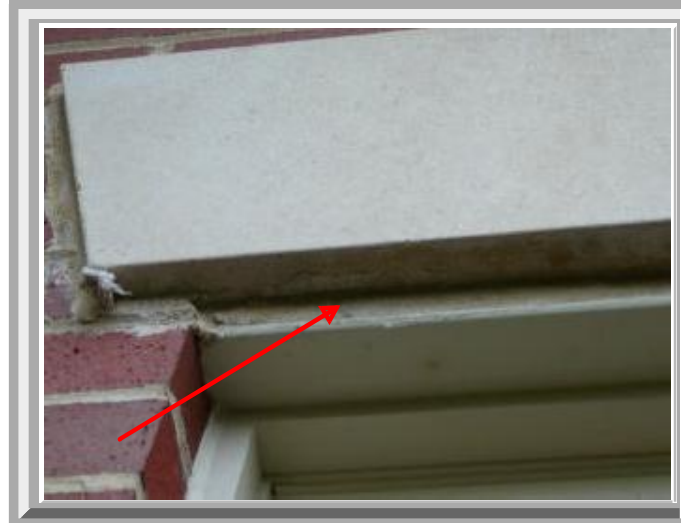
13

There is no visible flashing @ the lintel under the east/front wall decorative stone lintels.

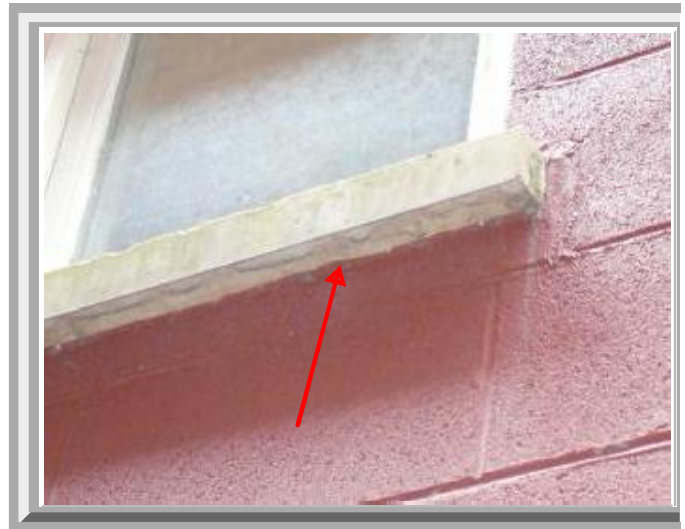
14

There is no flashing under the window sills; this can allow moisture to migrate into the masonry.

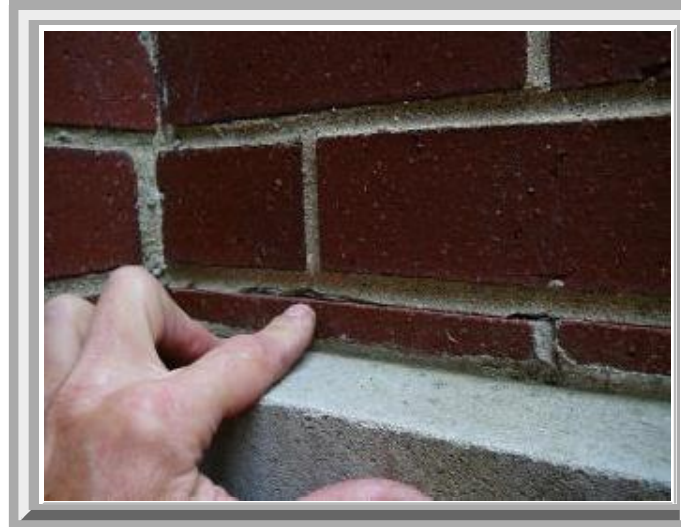
15

There is some flashing visible in various locations, but the material is very thin, and almost looks like cheap poly sheeting, similar to garbage bags.

This inadequate flashing material usually falls apart quickly, and provides little or no function.

In addition, the sloppy installation does not promote confidence that the underlying details (that can't be seen) are correct, which will negate function of the flashing.

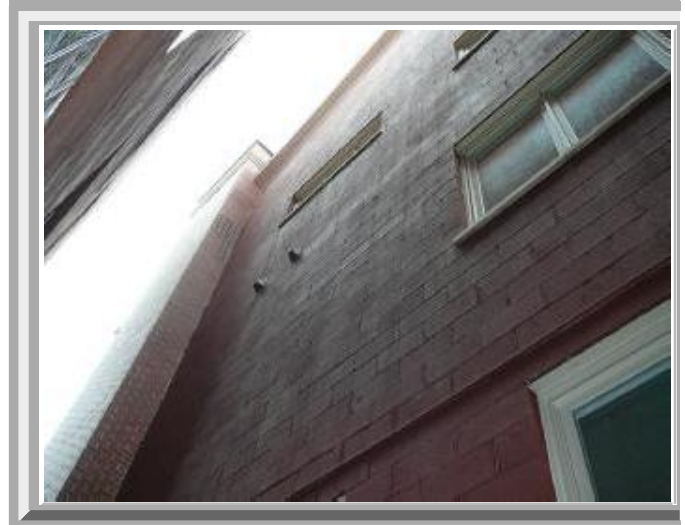
16

There is no visible or apparent flashing, wicks, or weeps @ the wall platforms.

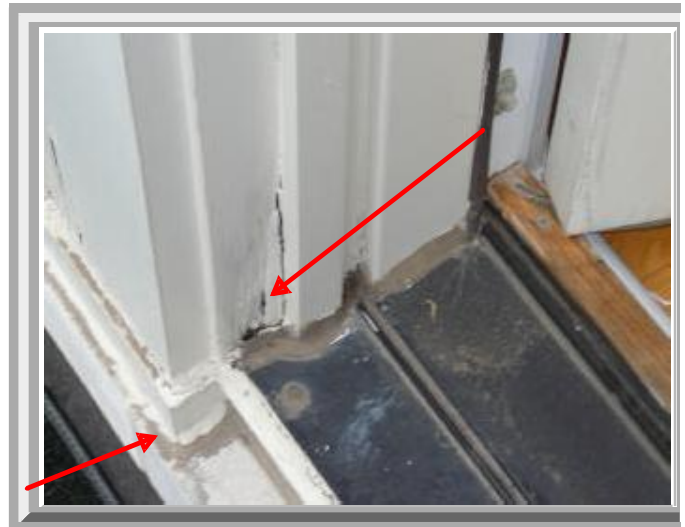
17

The door thresholds @ the east LR are decayed from lack of moisture proofing flashing details.

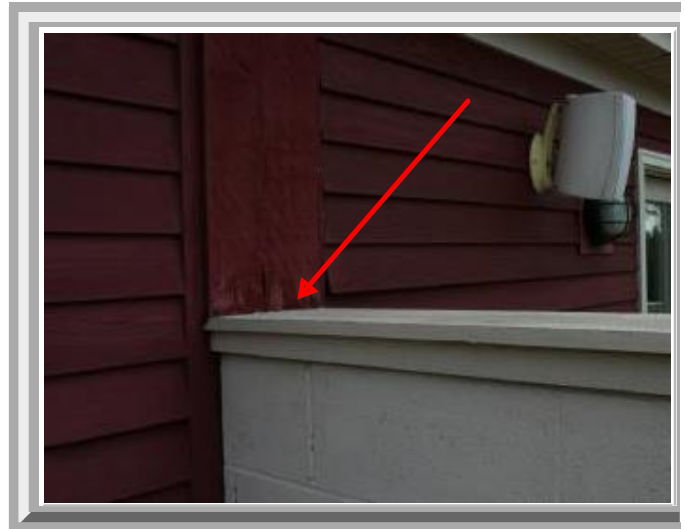
18

Upper rear 3rd fl. wall siding lacks flashing; the intersection of these walls could allow leaks.

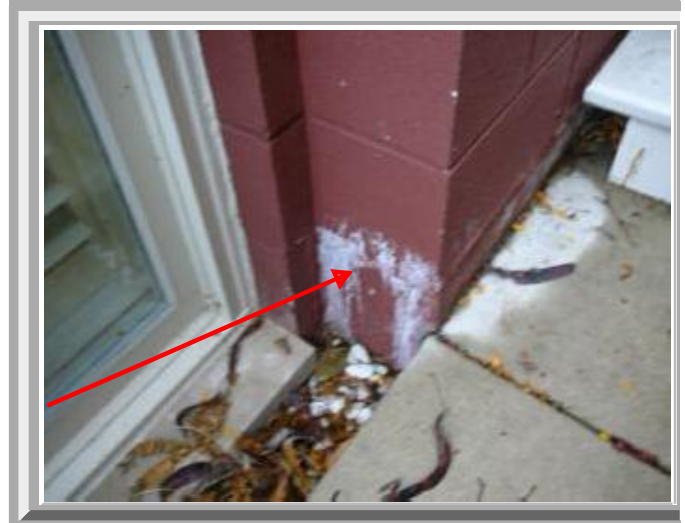
19

These stains are from moisture in the wall migrating back out again. They don't look like they are @ a flashing joint, i.e., water movement in the wall is uncontrolled.

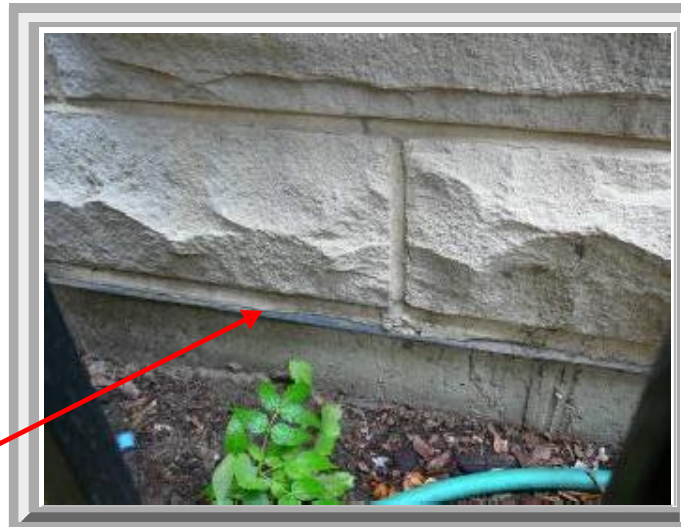
20

There is flashing in some locations along the front wall; it appears the masons understood there was supposed to be some flashing.

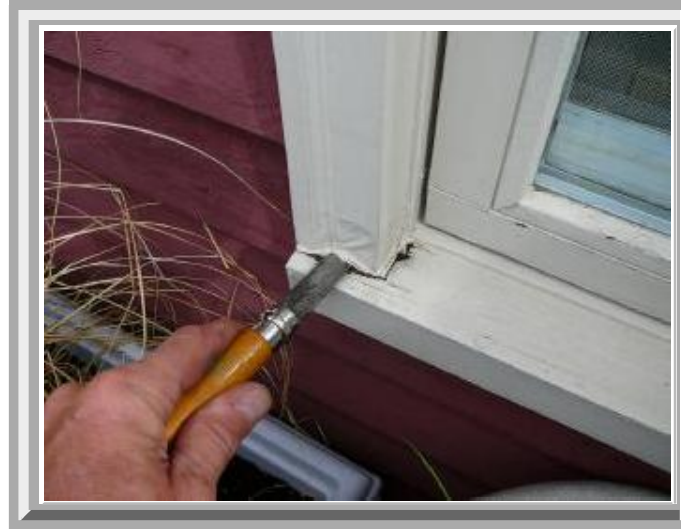
21

Rot @ a rear/west 3rd fl. window.

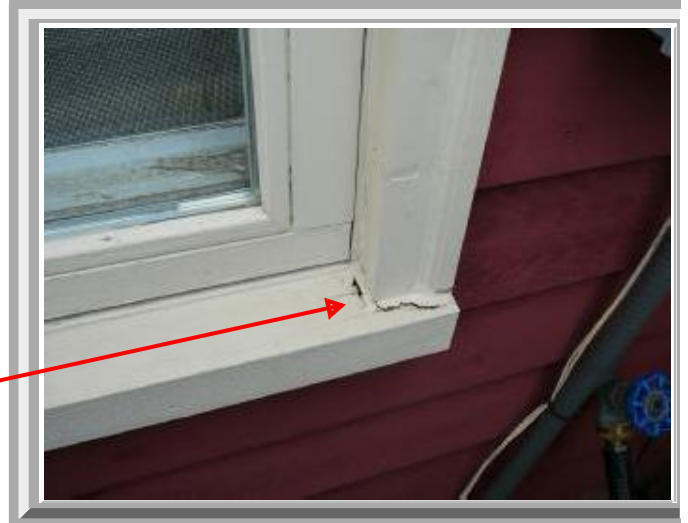
22

Opposite corner window rot.

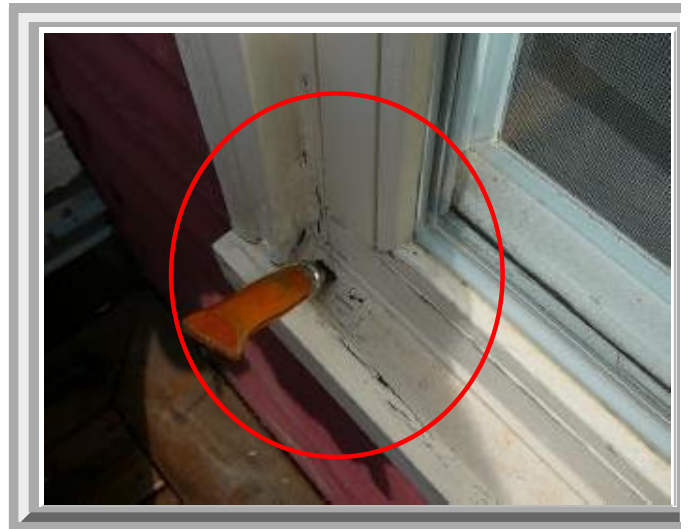
23

Badly rotten window frame; this rot could be migrating into the building structure.

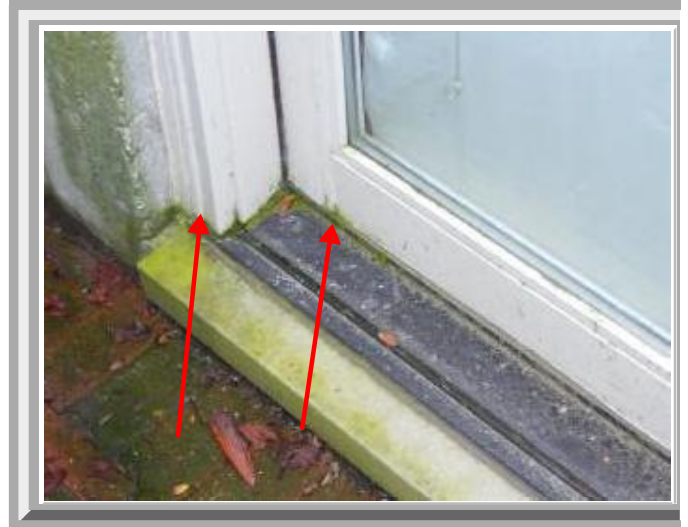
24

Mold & mossy growth along the lower level sliding doors; this means elevated moisture.

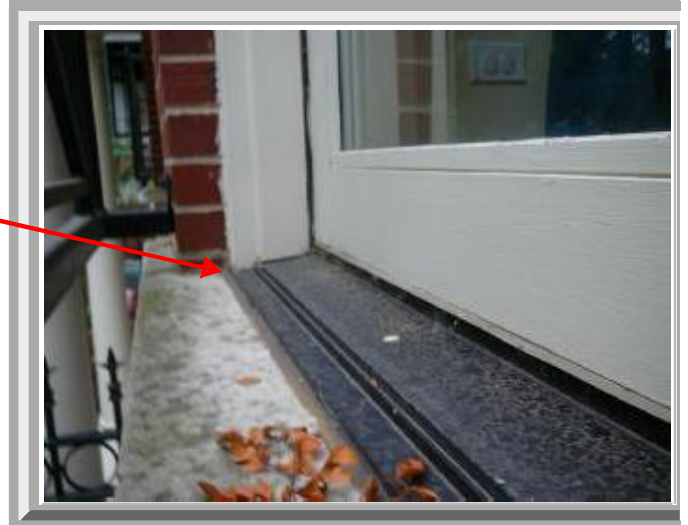
25

No flashing @ the sliding door thresholds; lack of flashing in these locations almost always leaks. The caulk joint just doesn't hold up adequately.

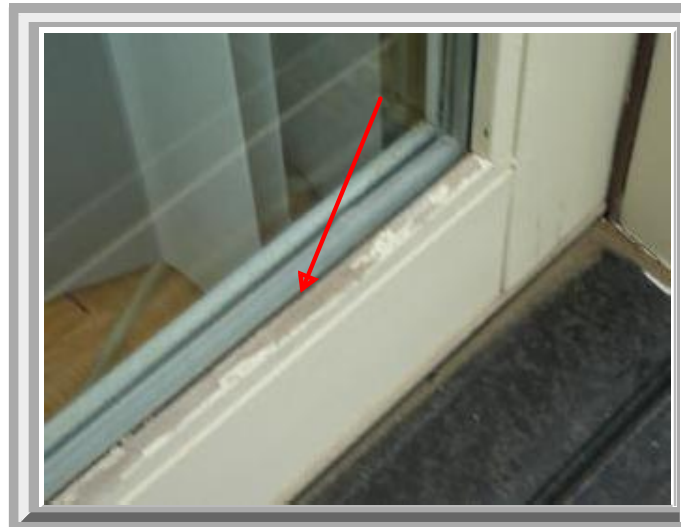
26

Worn finish @ the window & door frames.

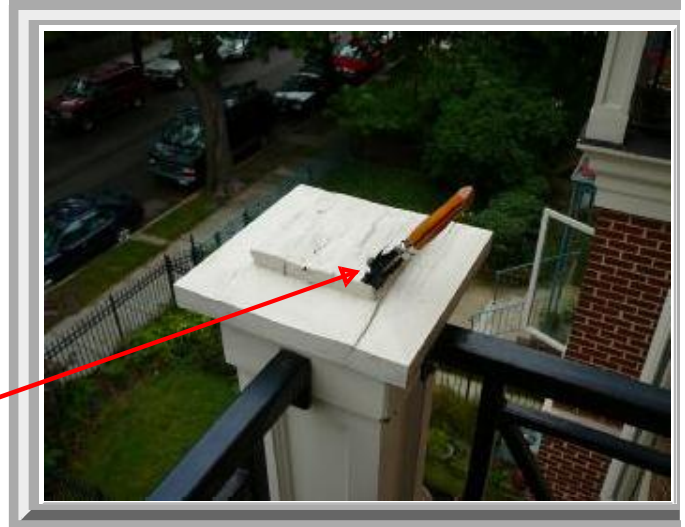
27

2) The front bay upper balcony guardrail support posts are completely rotten and falling apart. They could fail catastrophically under load. The guardrail balusters have spaces >4"; this could allow small children to fall through the railing. The iron portion of the railing is not fastened properly to the masonry; it could fail under load. In at least one location, there are no fasteners securing the railing @ all.

Totally rotten front balcony guardrail support post.

These posts could fail catastrophically under load; they are a life safety hazard.

The railings need to be rebuilt immediately; they are an imminent life safety hazard.

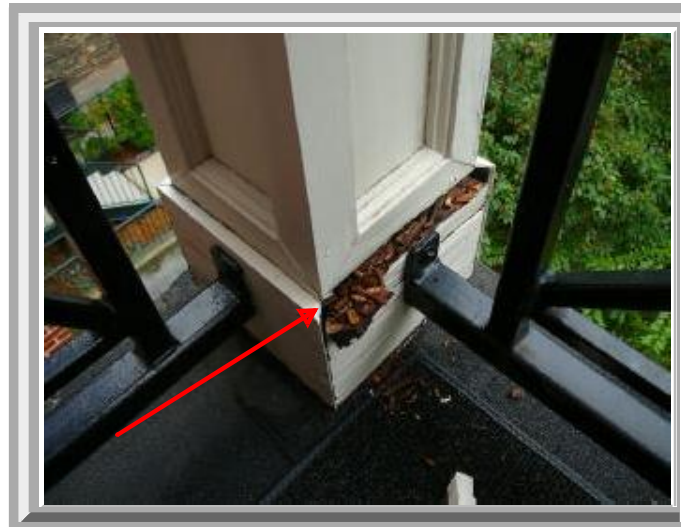
29

Some of the posts are literally falling apart.

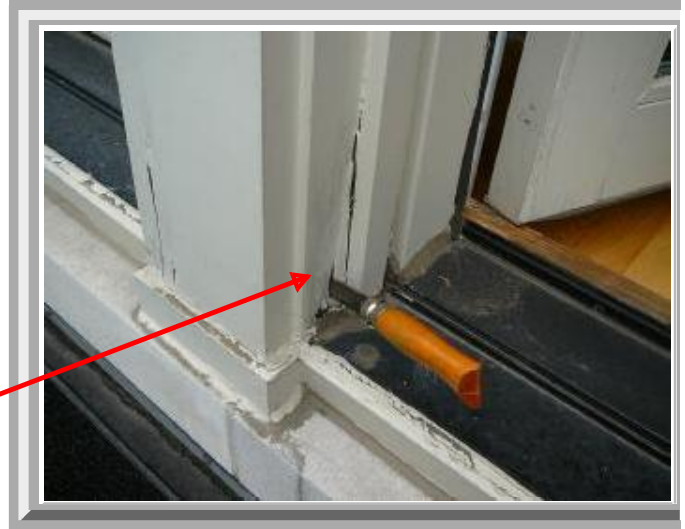
30

Rotten door frame @ east LR door.

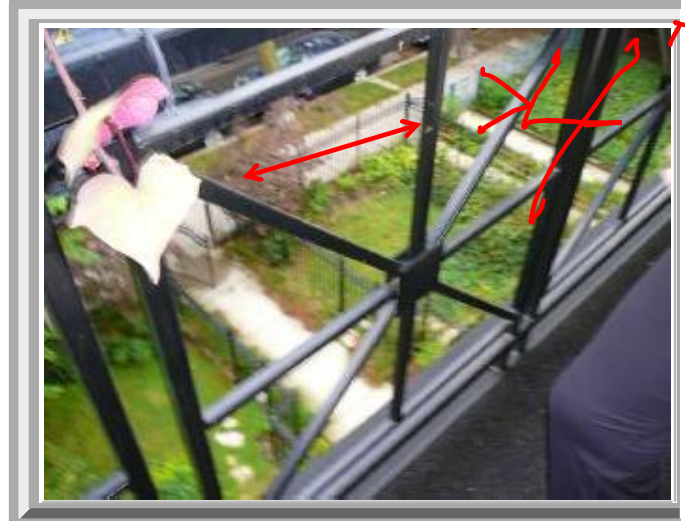
31

These railings have spaces >4" between the baluster details; this can allow small children to fall through the railings & be severely injured or killed.

All guardrail model codes have indicated maximum 4" spacing in railings for the last many years; I don't know how this passed the the municipal inspection.

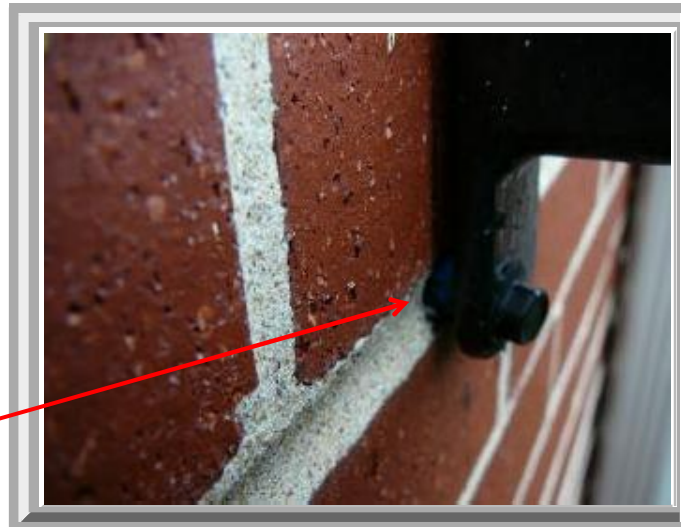
32

The railings are secured into the masonry w/ tapcon bolts, or other fastener(s) that are not approved for this application. They could fail catastrophically under load.

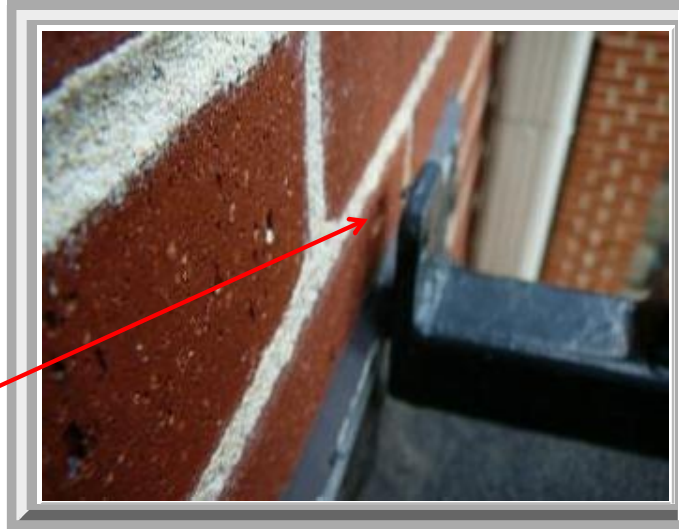
33

This railing "attachment" isn't; there is no fastener whatsoever. This is a life safety hazard.

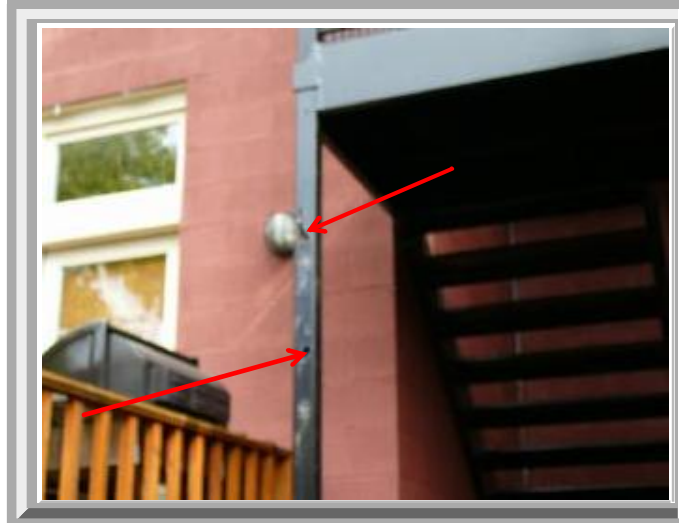
34

1) The rear steel egress stairs are badly deteriorated; the NW support post is holed through from rust in several locations, as are stair treads. The porch is in bad enough condition, it's conceivable it could fail catastrophically under load. The porch should be repaired or rebuilt immediately.

The rear egress stair support post is totally rusted out; it could fail catastrophically under load.

The rear porch egress stairs should be rebuilt, or otherwise repaired immediately.

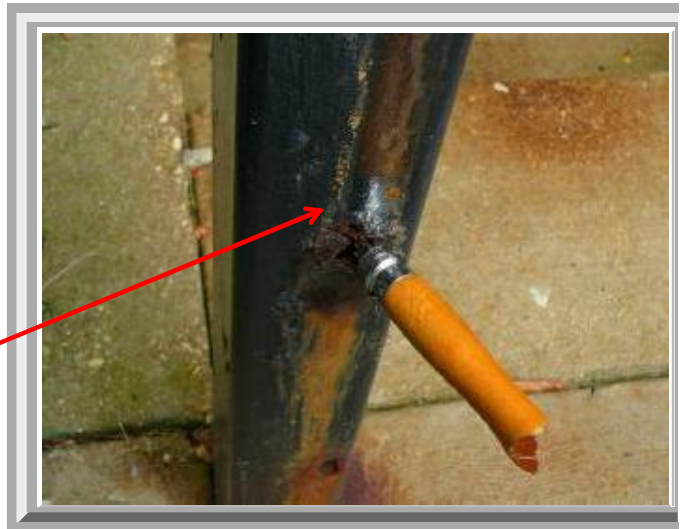
35

Close up of the steel support; this (very dull) knife can be pushed right through the steel.

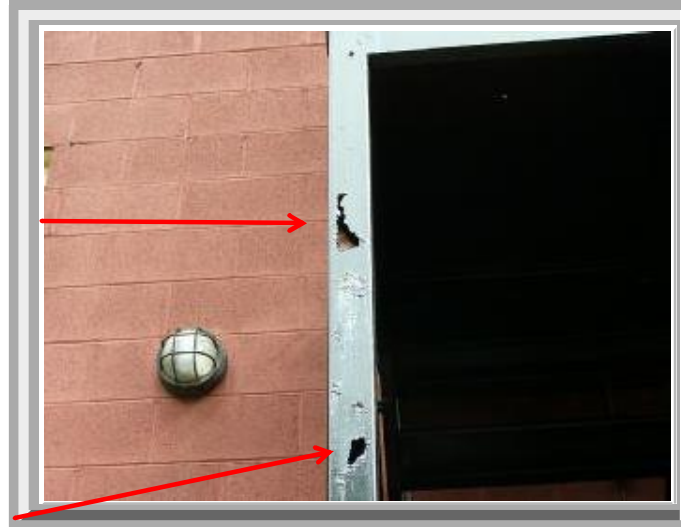
36

Another closeup; this post is gone.

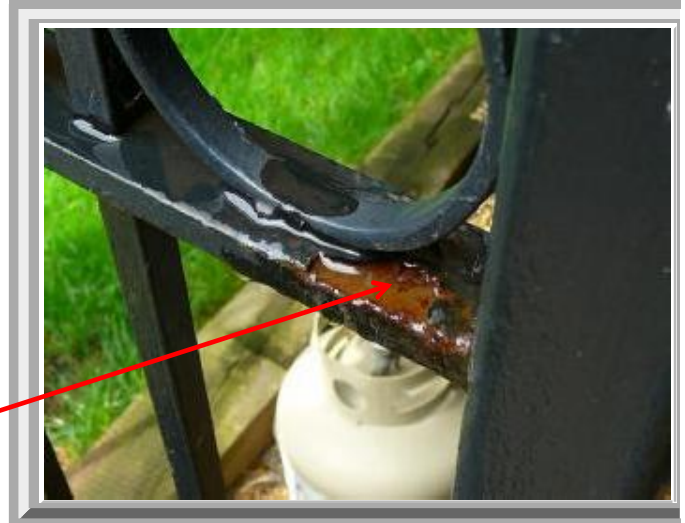
37

Railing rust @ the rear; the metal fencing & guardrails all need to be completely sanded down & refinished w/rust inhibitive paints.

After the porch is repaired/rebuilt, it should be sanded down & painted w/rust inhibitive paints. This is a substantial job.

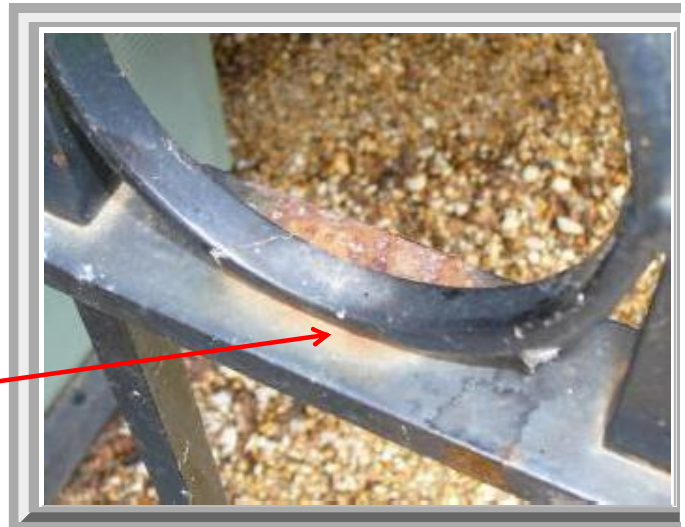
38

More of the same.

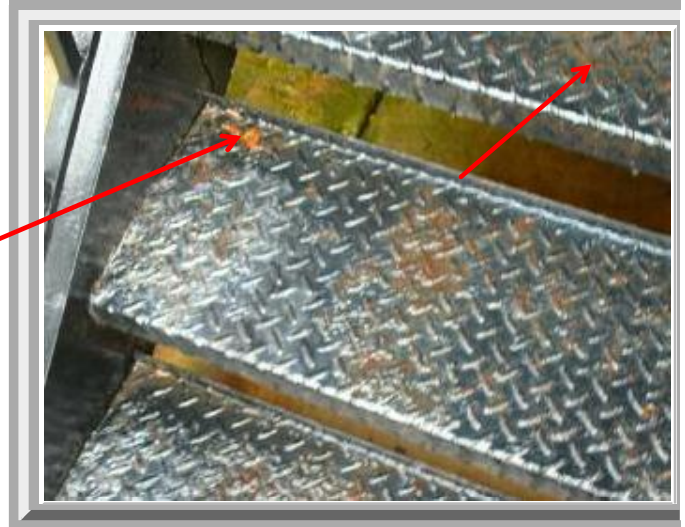
39

The rear egress stair treads are also rusting out.....

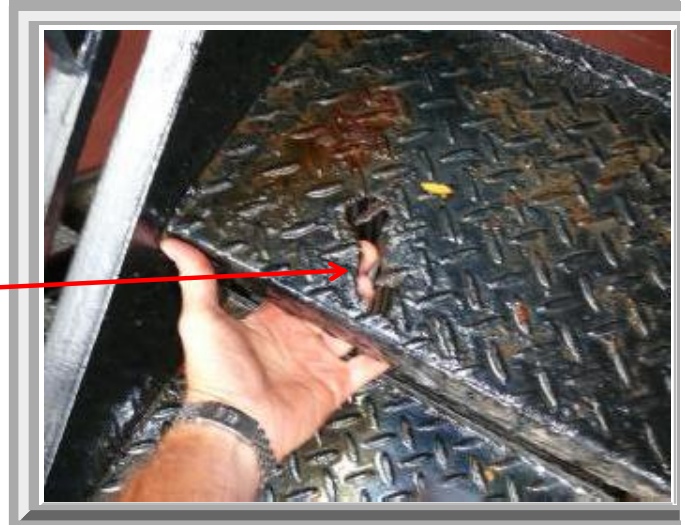
40

.....and entirely holed through in spots.

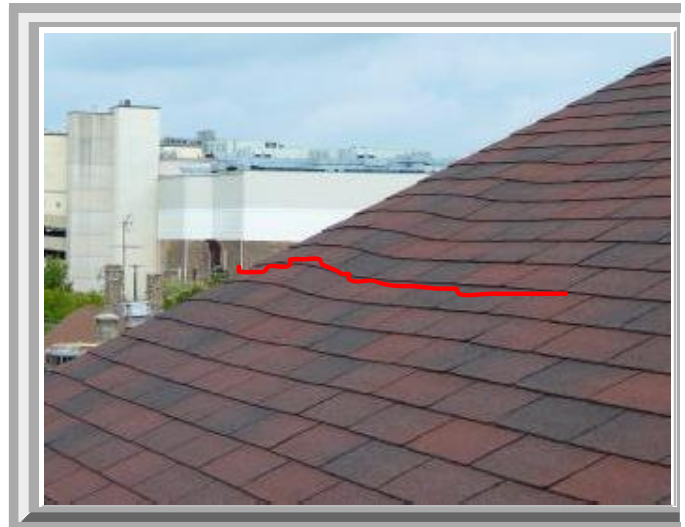
41

1) There are several locations where the roof sheathing (the plywood that the shingles are installed on) is buckled up. This is usually caused by improper installation where there are no gaps between panels to allow movement, or lack of ventilation that causes moisture to condense in the assembly & makes the panels warp, or both.

Undulation in the roof indicates inadequate carpentry, possibly on several points.

This could represent structural defect(s), moisture problems caused by leaks, inadequate roof ventilation, improperly installed vapor retarders, or simply poor quality carpentry.

Given the lack of venting & the obvious other roof defects, I have to be suspicious of leaks or problems caused by elevated moisture levels.

This is a large problem. There is no particularly good way to repair this condition without tearing the roof off and starting over. You might be able to find someone willing to attempt a repair, but until you find them, I have to think this repair means removing the roof & starting over.

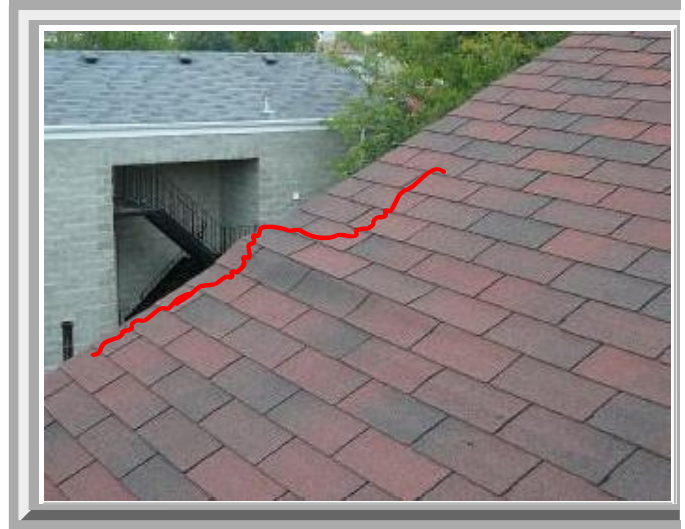
42

Another hump in the roof; this could be caused by inadequate spacing in the plywood roof sheathing,

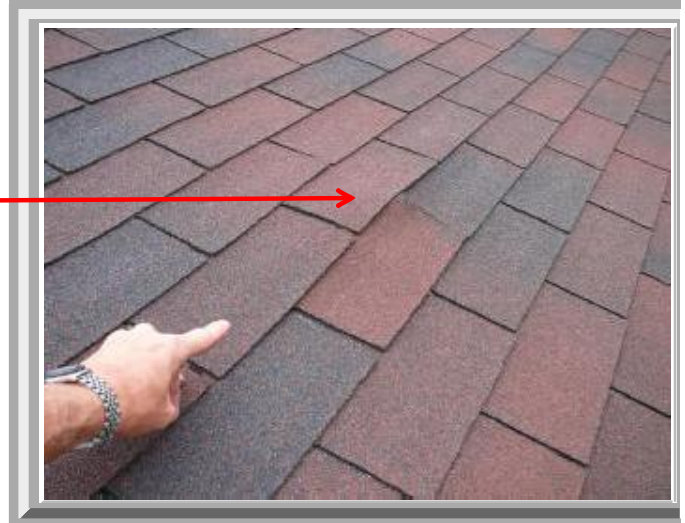
43

This is a surprisingly large hump in the ENE roof quadrant; the plywood is coming completely loose & lifting off the structure.

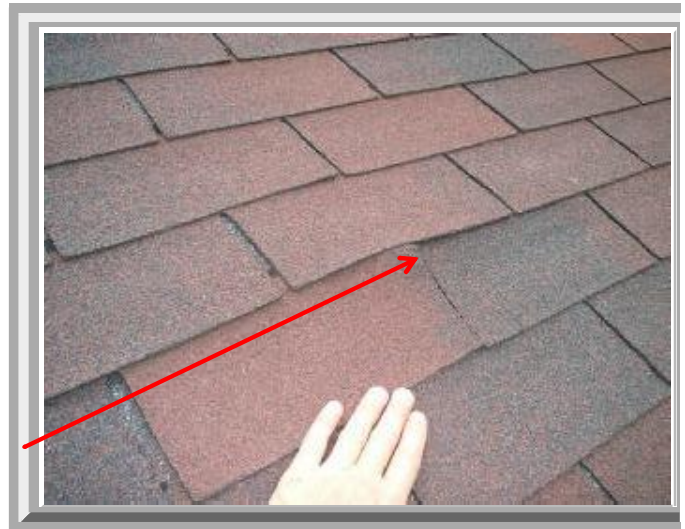
44

Another angle on the same defect.

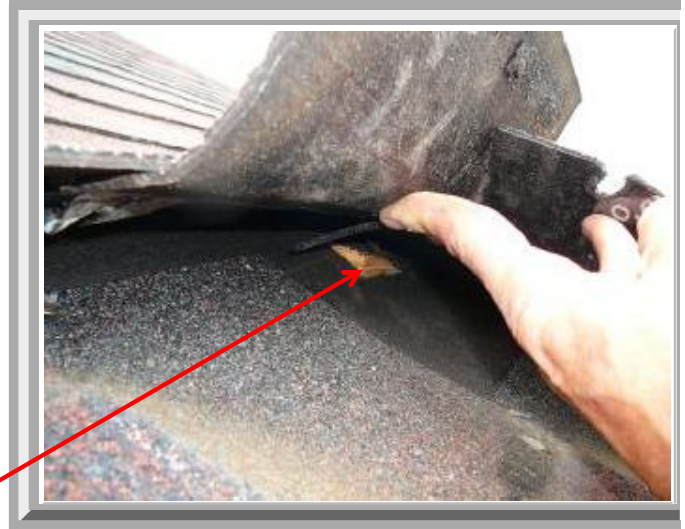
45

I lifted up the shingles in this location (they are completely loose), and I could see the corner of the ply sheathing lifting up.

It is damaging the shingles, and it will leak. It might be leaking already.

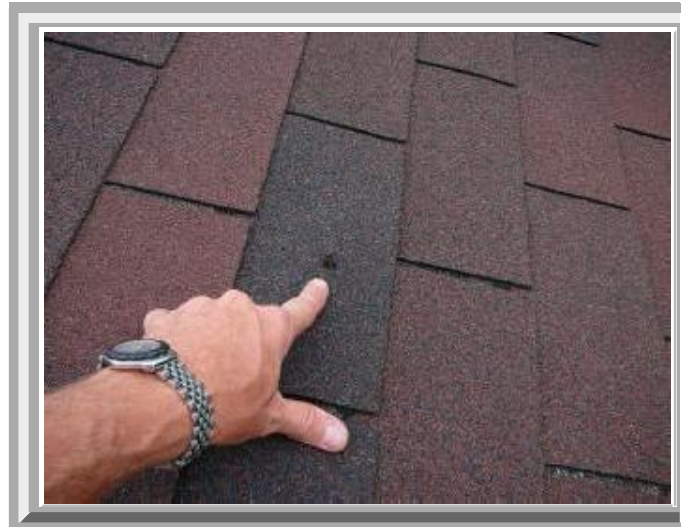
46

Nails backing out through the shingles; this is often an indication of elevated moisture.

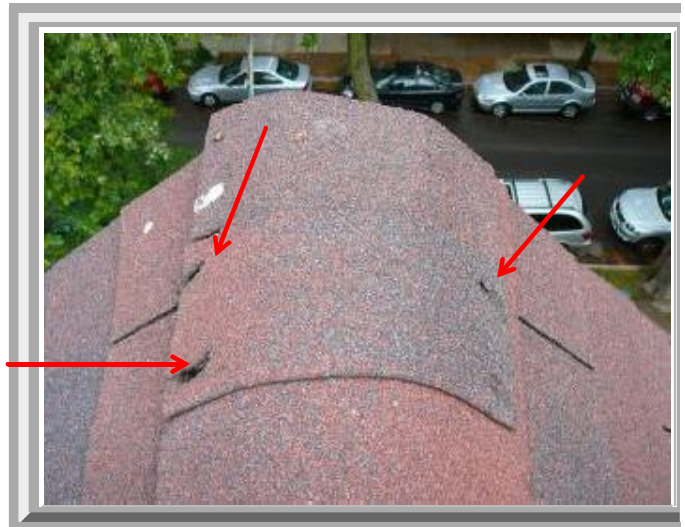
47

Nail pops @ the front south gable ridge.

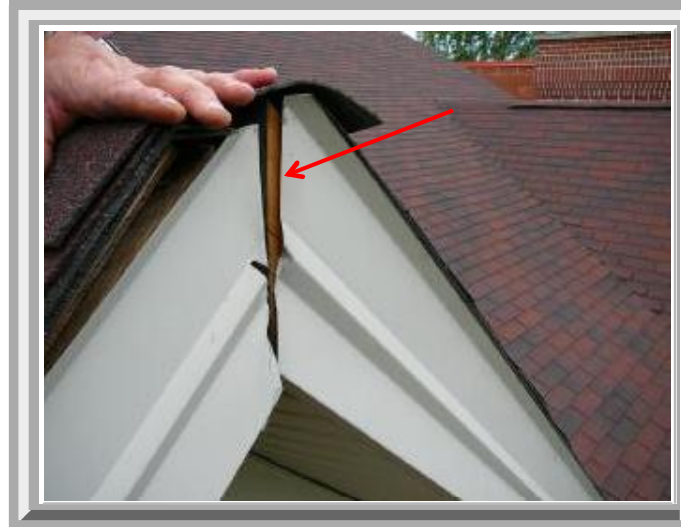
48

This same ridge is separated and in very poor condition; it looks like the rake boards have separated from the ridge.

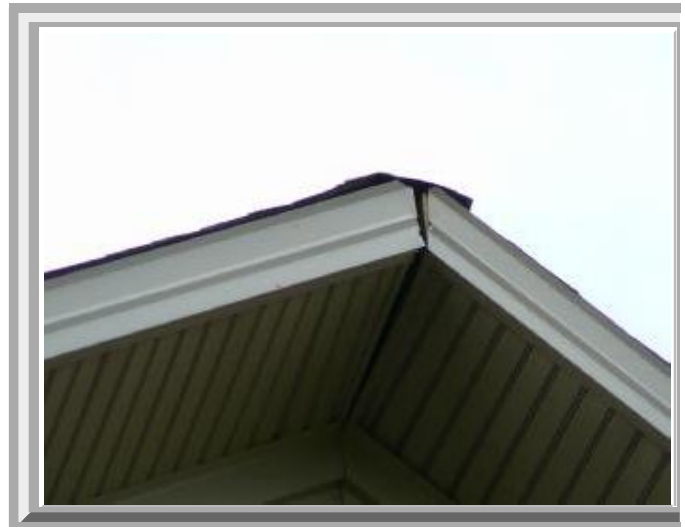
50

The south gable peak is separated by a wide margin (approx. 1"). I honestly have no idea why, other than to suspect there is some underlying unsatisfactory structural framing, or possibly blocking that was omitted. At this point, the aluminum should come off so it can be repaired properly, and when the aluminum is off, you call me to determine what repairs might be necessary.

View from below.

I suspect there is a lack of structural blocking holding the framing together.

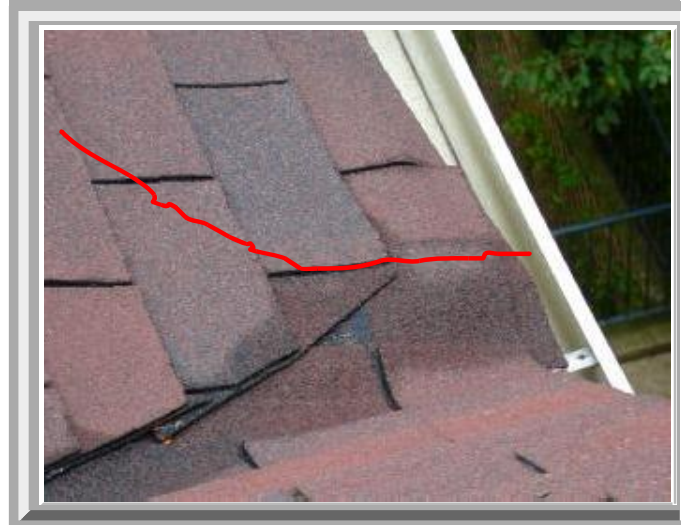
52

NNE roof valley; the roof "flattens" out in this location.....

The resulting lack of drainage will cause the roof to leak or fail prematurely.

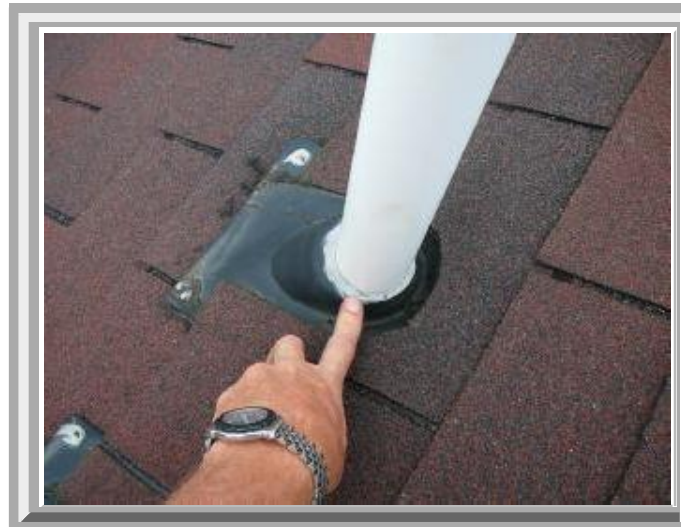
53

Caulk around the base of the gas vents @ the roofline; caulk should not be used in this application; the wrong caulk can actually damage the flashing.

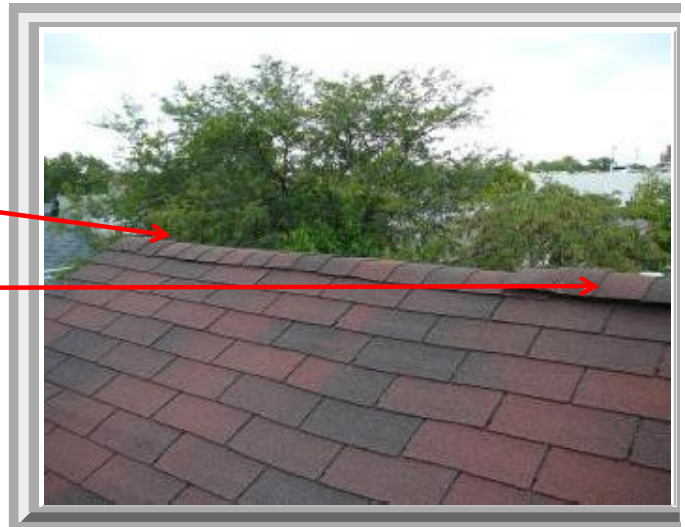
56

No ridge vent on large portions of the roof.

No venting here.....

But there is here.....

Not extending the venting to the end of the roof is a sloppy install.

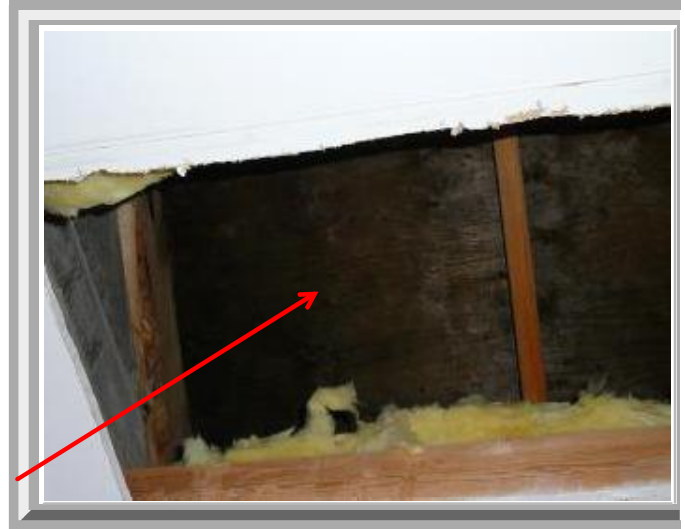
57

Blackish mold on the underside of the sheathing above the north unit "attic" access.

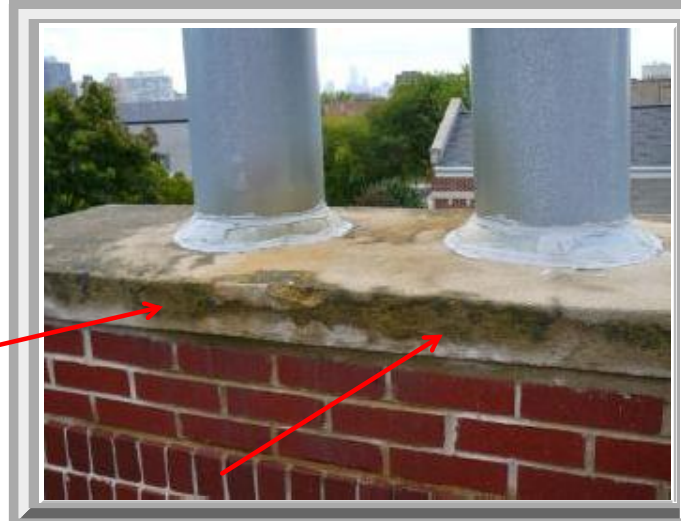
58

2) The chimneys are soaking up water and falling apart; the crowns are literally saturated, and growing moss & mold. I'm not entirely sure why, but I suspect the initial concrete installation wasn't finished or sealed adequately, and the crown simply soaked up a lot of water.

The chimney caps are soaking up water badly, and already falling apart from saturation & freeze/thaw damage.

These chimneys should be rebuilt in the near future, the sooner the better. If you wait, they will need complete rebuilding.

The chimneys need new caps.

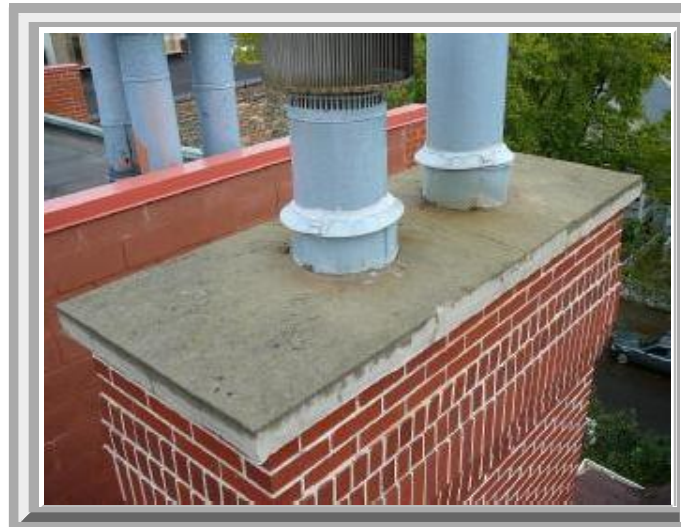
59

Another view of same.

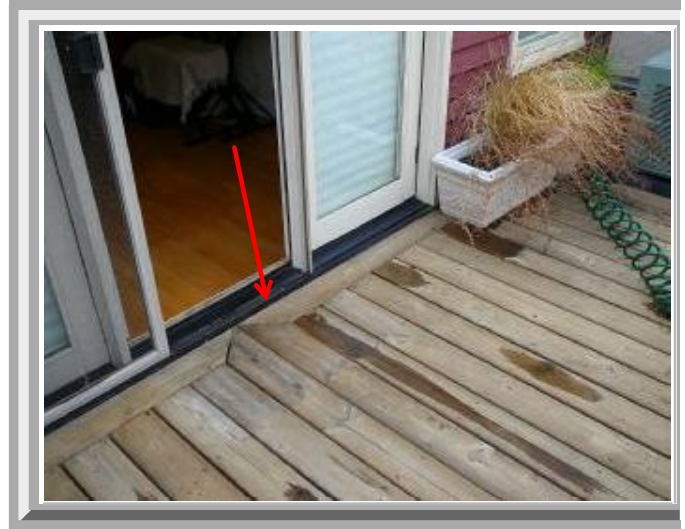
60

There is no curb between the deck elevation & the door threshold; snow & ice will pile up against this joint, and it is a common location for leaks.

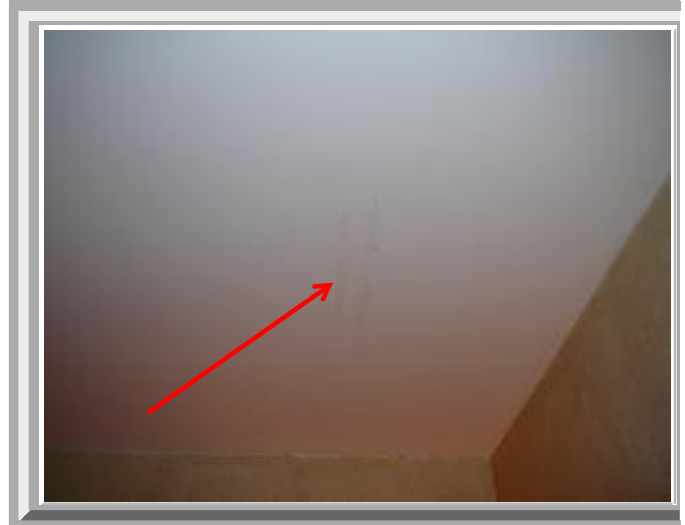
61

Water stains @ the ceiling of the 3rd fl. BR.

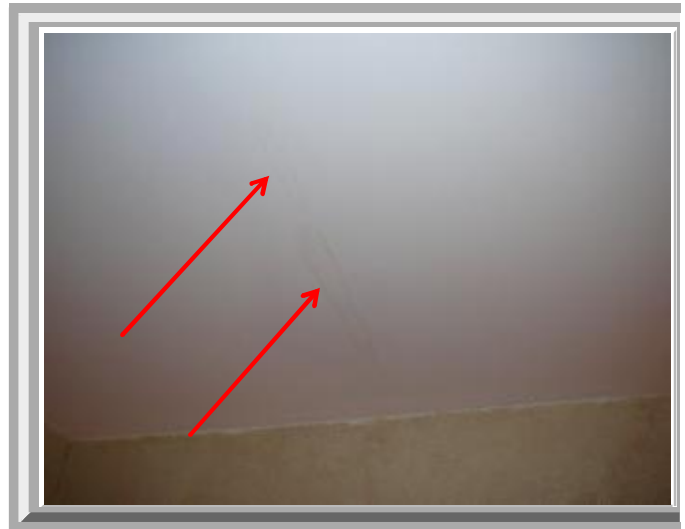
62

More of the same.

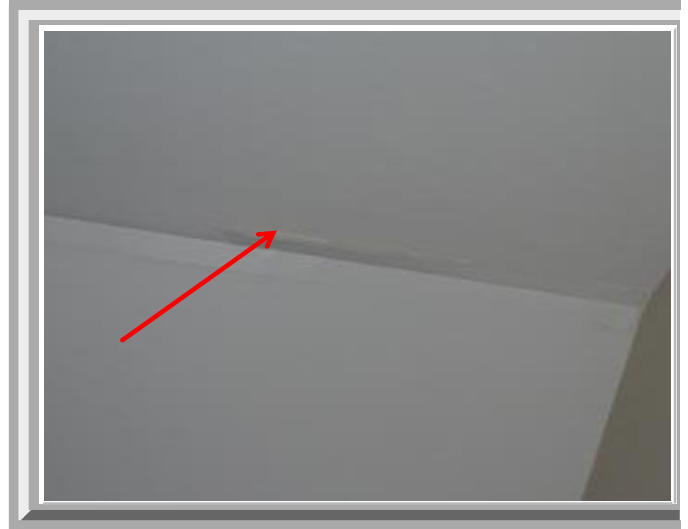
63

More water stains/leak stains @ the ridge of the BR.
