Kurt Mitenbuler & Associates, Inc.

Property Inspection location:

Inspection Date Monday, October 1, 2007

Photolog of Major Concerns

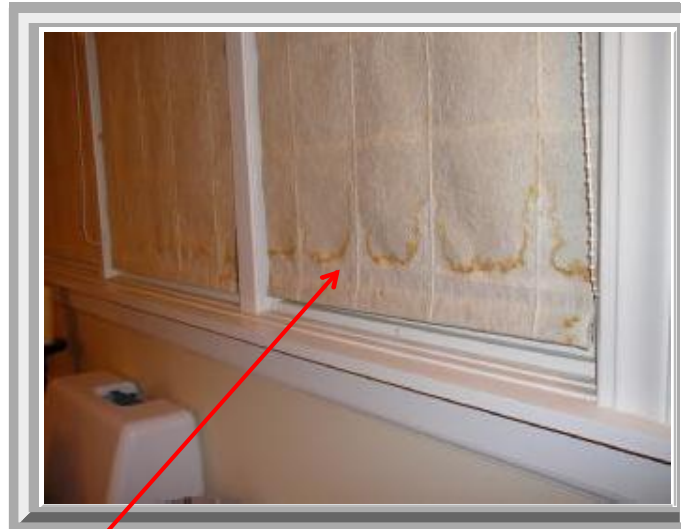
64

Badly water stained drapes @ the north wall; water apparently came raining down through the window opening.

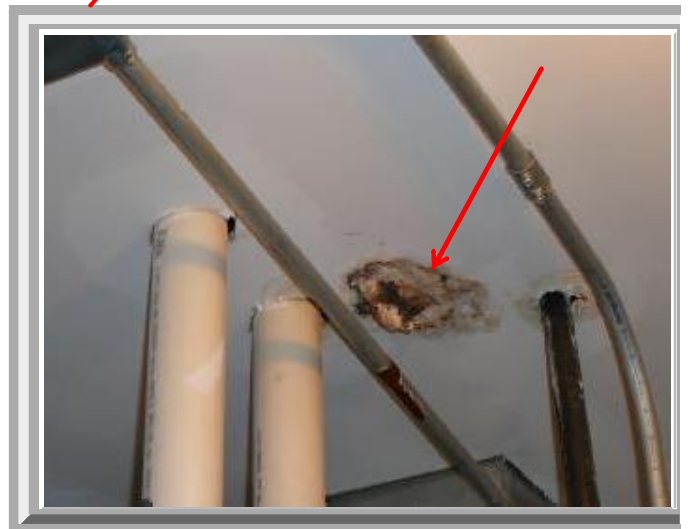
65

Water damage & leak stains @ the ceiling of the mechanical room.

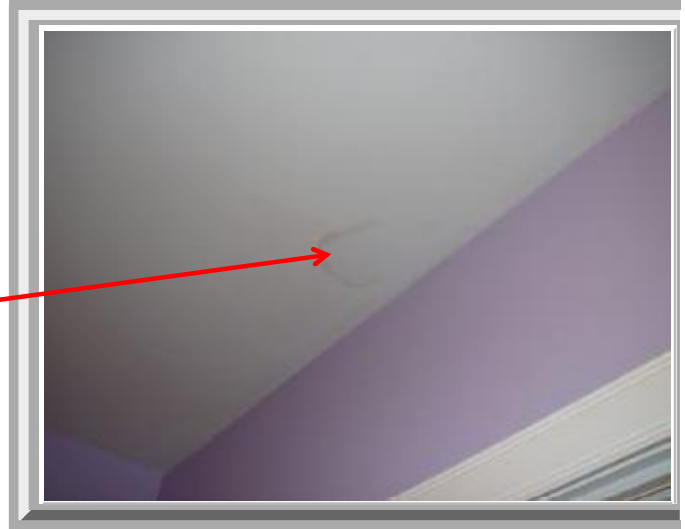
66

More water stains @ the lower level apt.

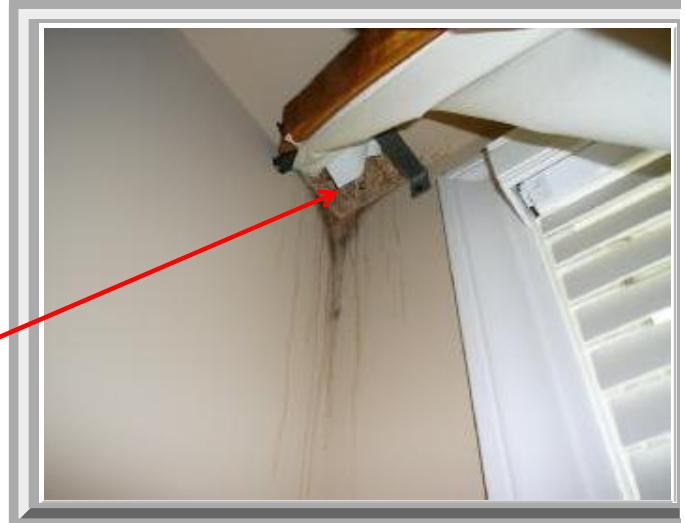
67

Major water leak @ the lower level FR sliding door.

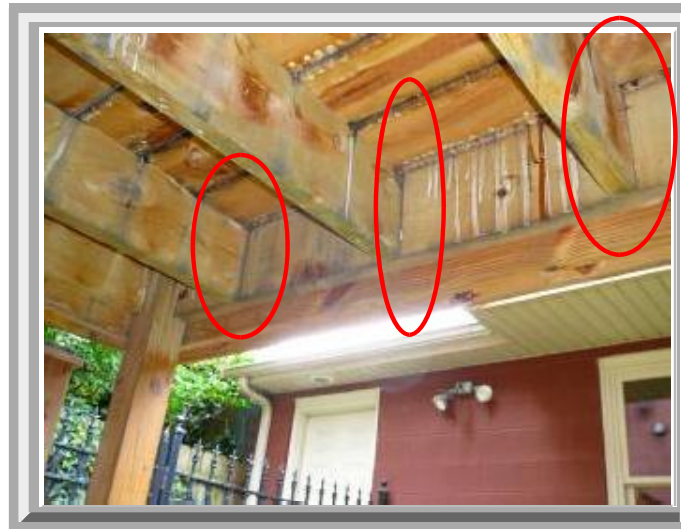
68

3) The rear steps/porch decks lack joist hangers @ the joist connections; this could allow the joist connection to fail under load. All the treated wood step assemblies should have joist hangers, strapping, and metal reinforcement to prevent failure.

The rear porch/deck lacks joist hangers @ the joist connection.

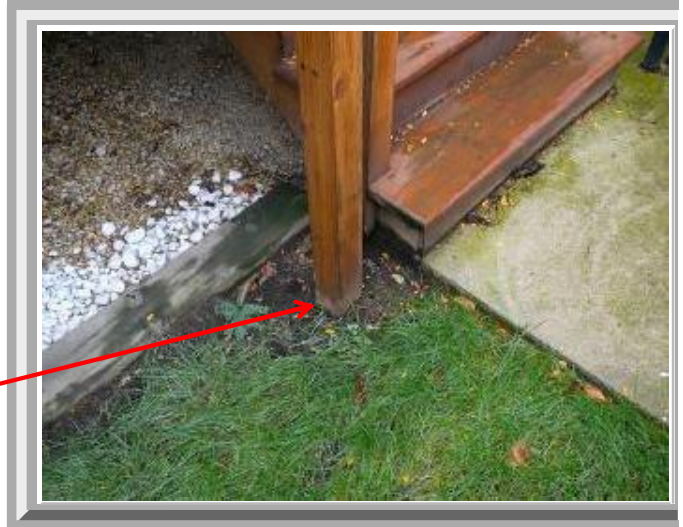
69

The porch posts are not set on footings; they could settle.

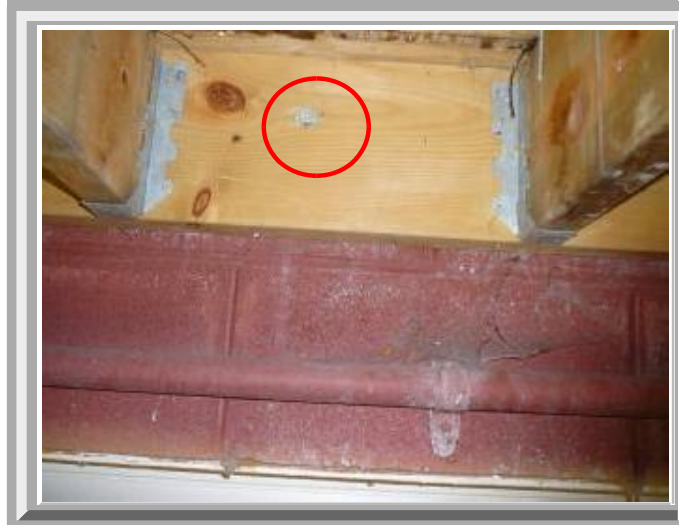
70

Ledger board has inadequate fasteners.

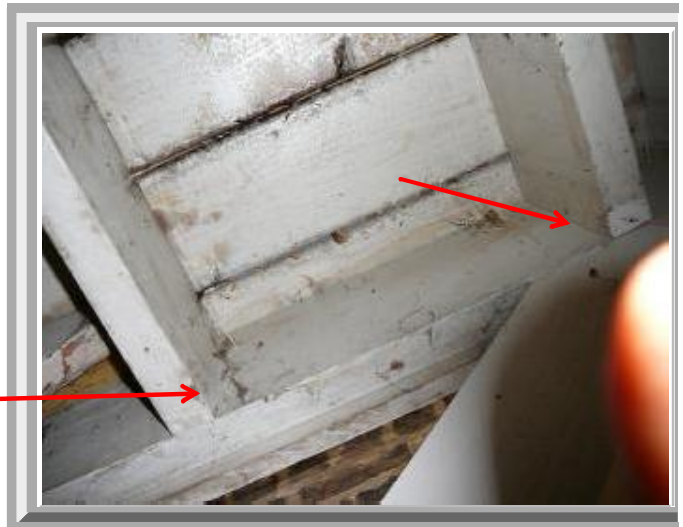
71

No joist hangers.

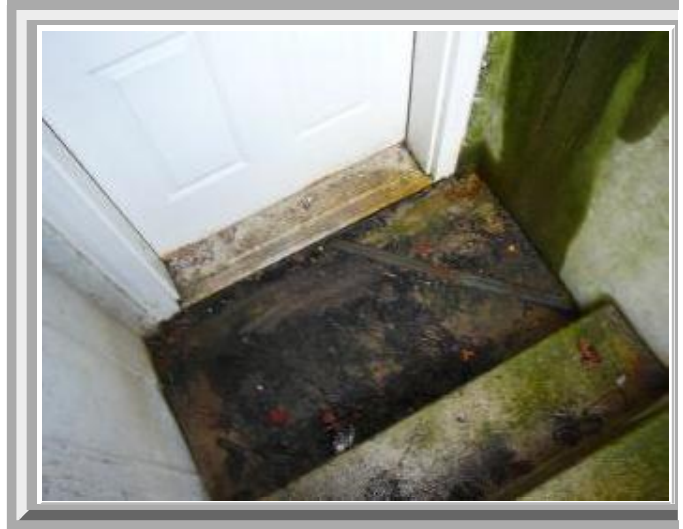
72

Lower level rear bsmt. entry doesn't look like it drains adequately; there is no floor drain in the areaway.....

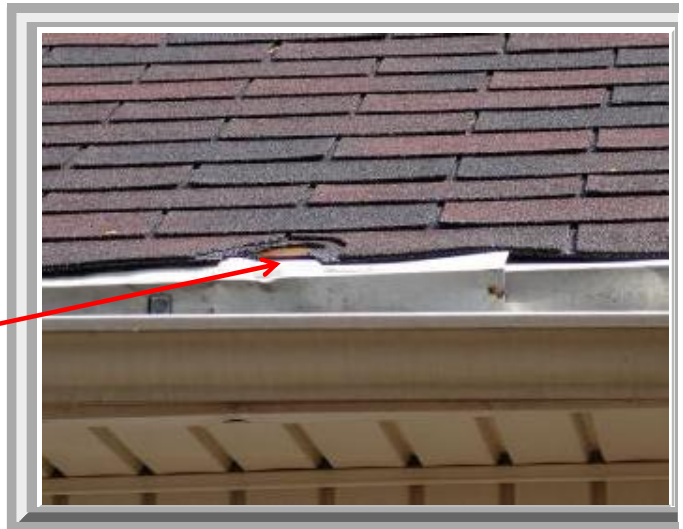
74

Damaged roofing @ the west garage eave.

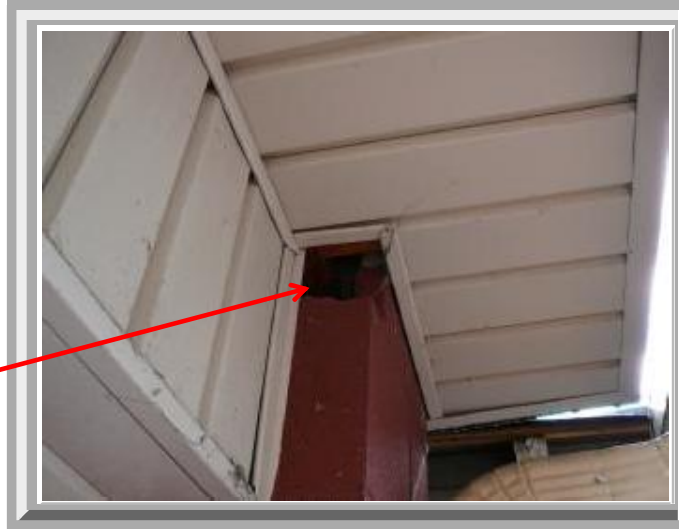
75

Missing brick @ the garage/west wall.
