## **Kurt Mitenbuler & Associates, Inc.**

### ***Property Inspection location:***

██████ W. Iowa  
Chicago, IL

**Date :** Tuesday, July 22, 2008

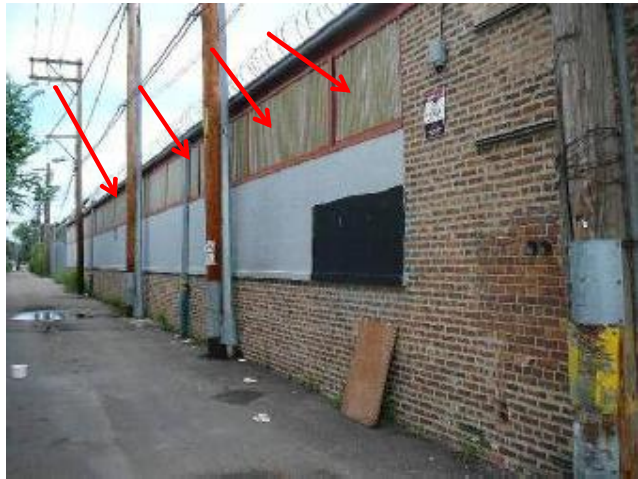
- 1) The rear/south upper clerestory window bank has dozens or more broken panes of glass. The broken glass should be replaced.
- 2) The south lower "window" bank is cheap fiberglass panels. The panels are almost totally weathered away, and are an exceptionally easy break in target.

3  
South lower "window" bank is cheap fiberglass panels. The panels are almost totally weathered away, and are an exceptionally easy break in target.

You should replace all the south window panels with a suitable material for energy efficiency and security.

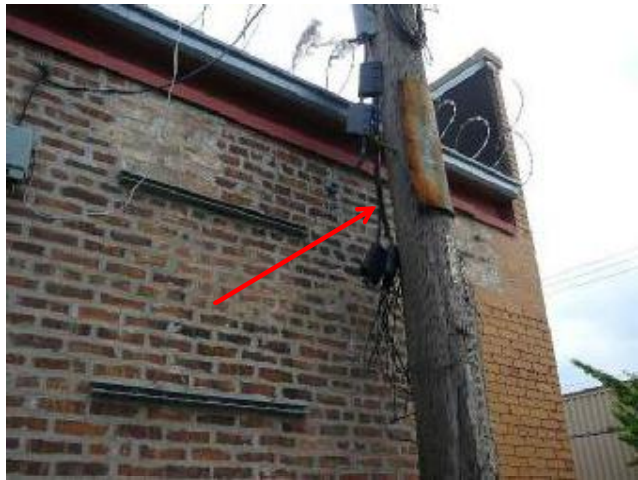
The entire electrical system has been stripped out by thieves for the copper. The service entrance conductors have been trimmed at the pole and are hanging there. The few pieces of service equipment still in place have been gutted for the scrap metal.

4  
The electric service is cut off. These service wires are left dangling on the pole.

There were no functional or salvageable electrical system components. You should start over with all new equipment.

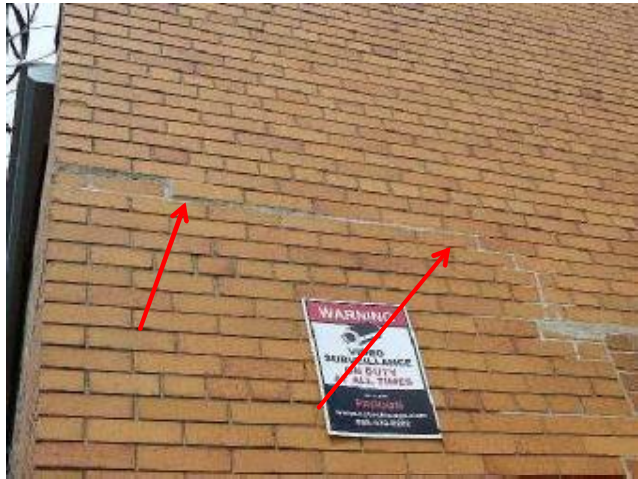
- 3) There are lintel jacking cracks at the corners of several of the old original 1st fl. street level window openings. All these old window openings have been bricked in for decades. It doesn't look like the lintels that originally caused the problem are even present anymore. The cracks have been caulked and repointed a couple times, but minor hairline cracks are reappearing.

6  
Lintel and settlement cracks at the NE corner.

Essentially, there are cracks around the old window openings. There's never been any thoughtful structural reassembly; it was probably bricked in the most expedient manner at the time. There will be more minor cracking over the years, but probably not anything substantial or significant. Make minor repairs as necessary.

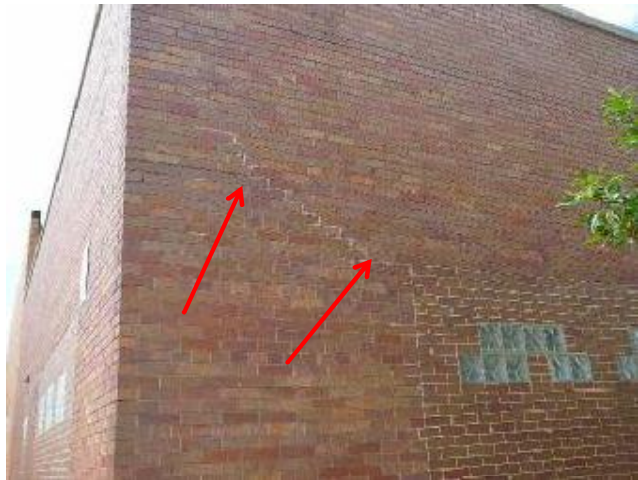
7  
Masonry cracking at the NE corner.

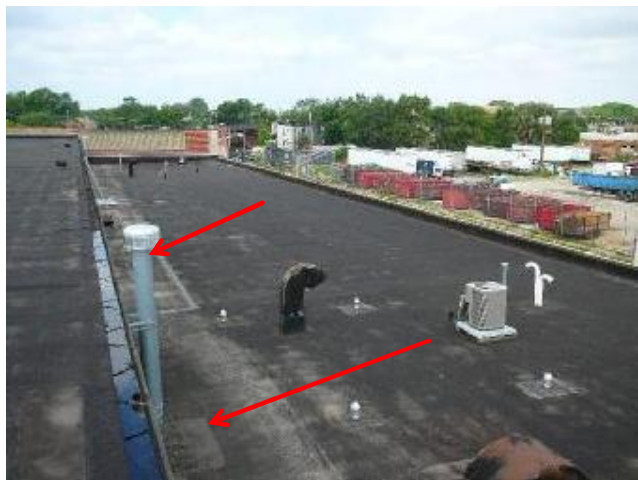
2) The upper middle roof drains onto the north lower roof. The north lower roof doesn't drain adequately, and there are large ponds along the wall junction with the middle building. Ponding water means leaks. There are multiple attempts at patching the roof in these areas, indicating there has been a problem.

8  
The north roof drains back against the middle building.

The north lower roof should be repaired so that it drains into the roof drains. If it isn't repaired, it will leak.

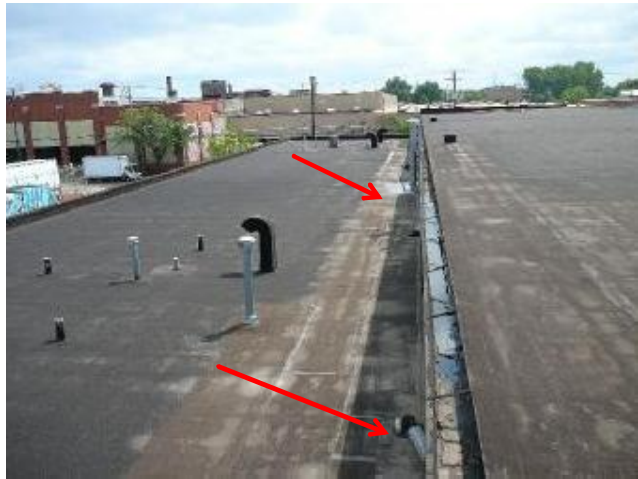
9 Patching along north lower roof section. This area does not drain well, and it has apparently leaked.

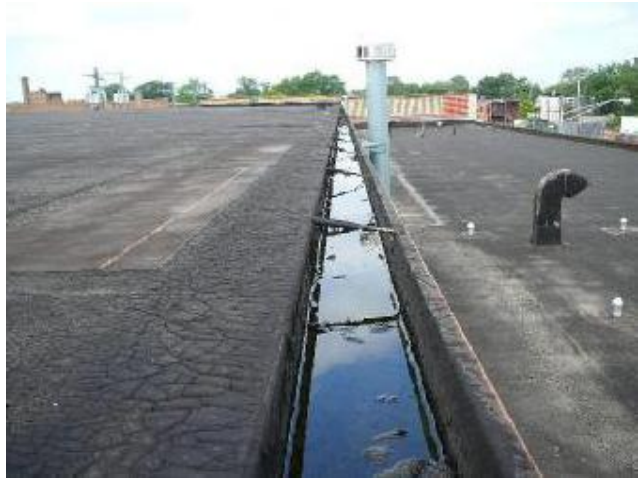
5) The gutters don't drain well. You should rehang the gutters to drain when the roofing is replaced.

10 The gutter doesn't drain well. The gutter should be reinstalled to drain.

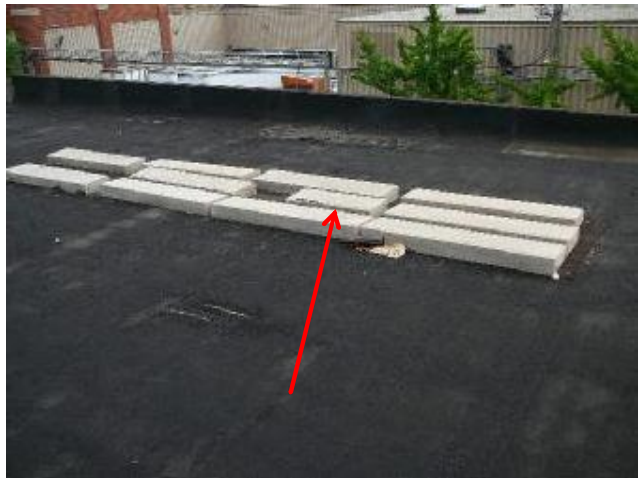
4) The east stone coping that should be installed on the top of the parapet wall is still laying on the east upper roof. These stones should be reset on the east parapet wall and pinned so they can't move.

11 The east stone coping that should be installed on the top of the parapet wall is still laying on the east upper roof. These stones should be reset on the east parapet wall and pinned so they can't move.

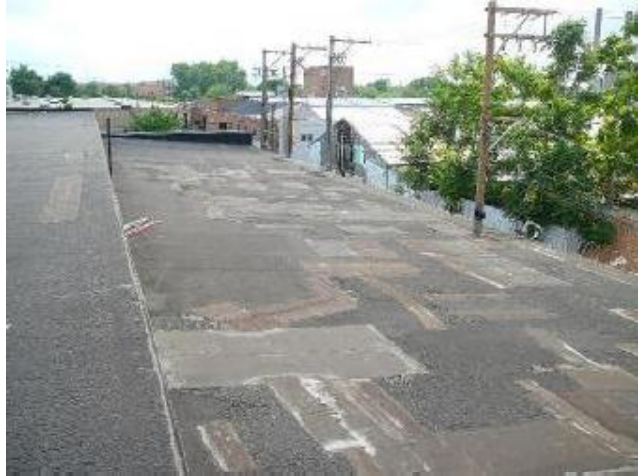
12

South lower roof; note the immense number of patched areas. Many of these patches could collapse catastrophically.

This is the suspected fuel tank vent pipe.

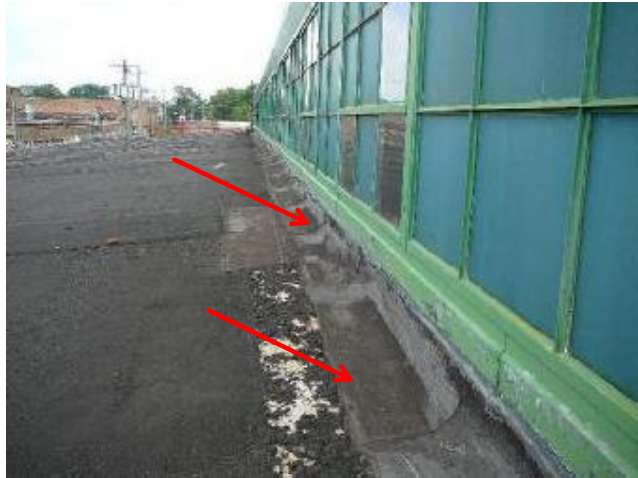
13

North edge of south lower roof. It is patched very poorly, and it leaks.

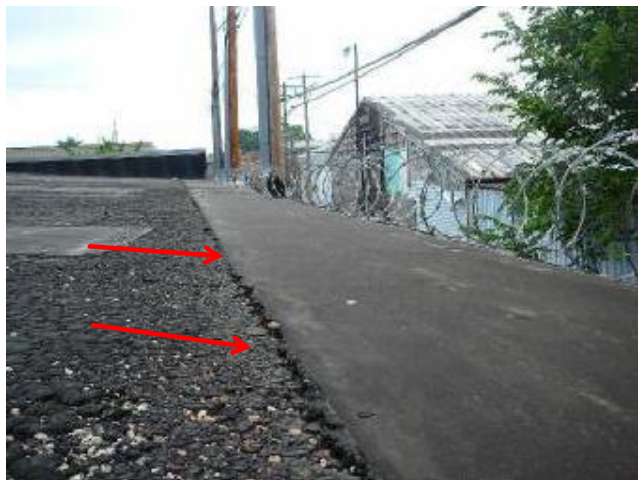
14

The eave at the south roof eave leaks profusely.

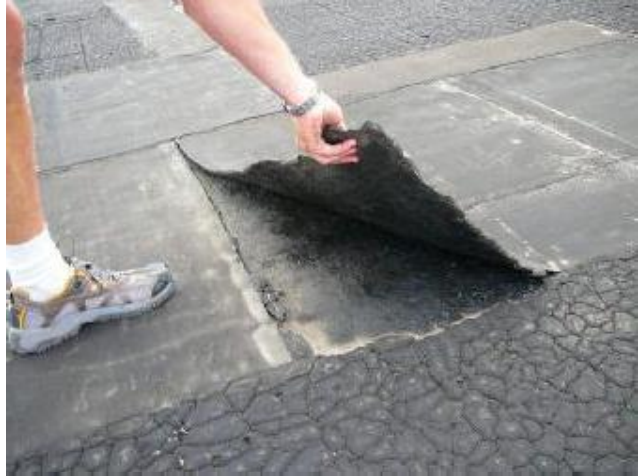
15

Delaminated roofing at the south roof surface.  
This area is leaking profusely and damaging the concrete roof panels.

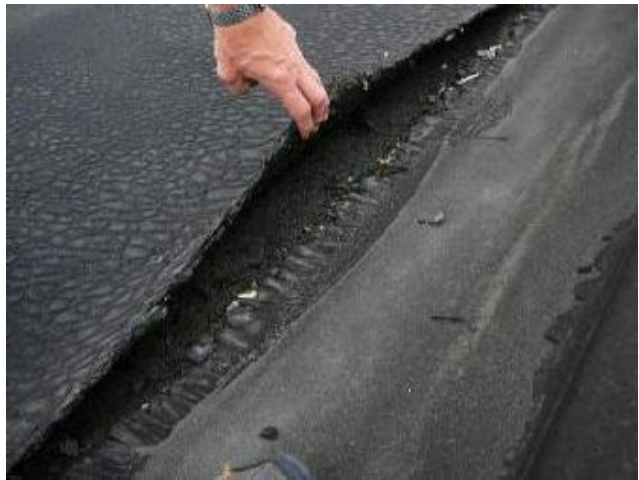
16

3) The north lower roof north eave edge gravel stop flashing has been patched with membrane, but the "repair" is completely failed. There is water under the roof membrane.

Delamination at the north parapet wall. This roofing is saturated underneath.

I can make strong arguments for replacing this entire roof, and I can also imagine ways that temporary repairs could have limited application so long as you maintain the roof membrane with very regular inspections and necessary maintenance repairs. Get an estimate of the costs of either possibility from the roofing contractor you have look at the south roof.

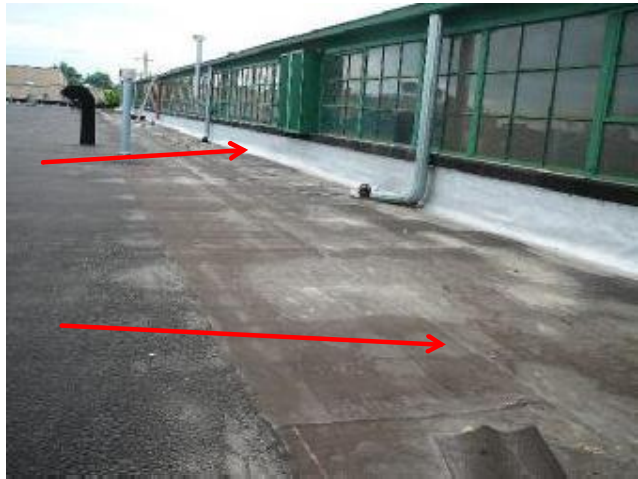
18

The north roof drains back against the middle building wall.

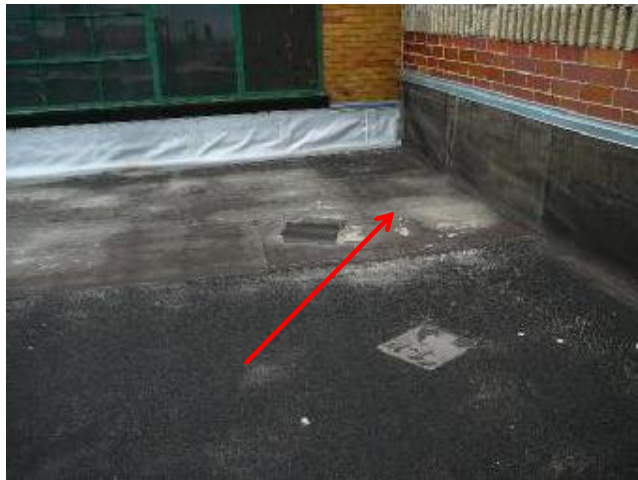
19

Ponding area at the north lower wall-middle window wall junction.

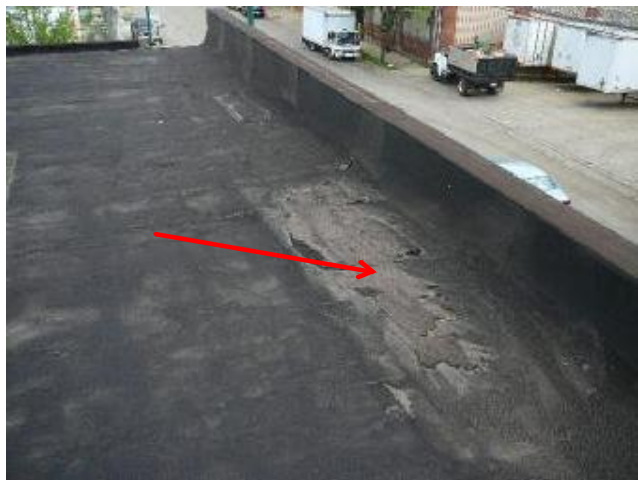
20

East upper roofing has been patched. It leaked.

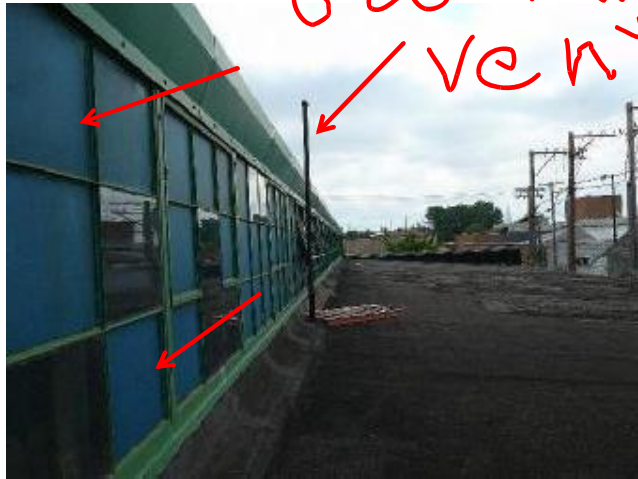
21

Broken out or missing glass at the south clerestory window wall.

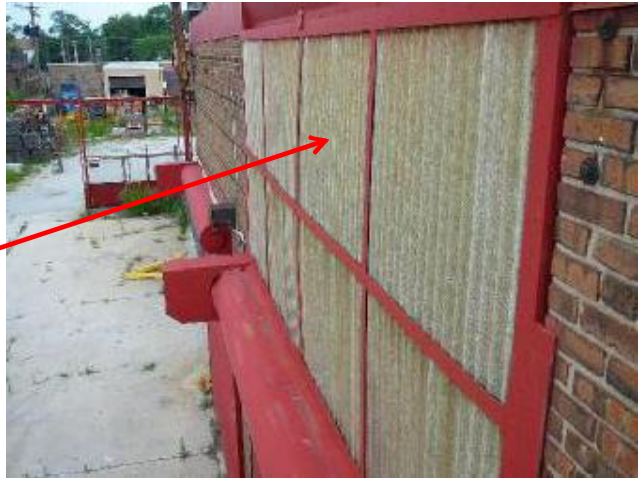
22

Fiberglass panels at the rear upper wall are badly weathered and deteriorated. They are going to fail.

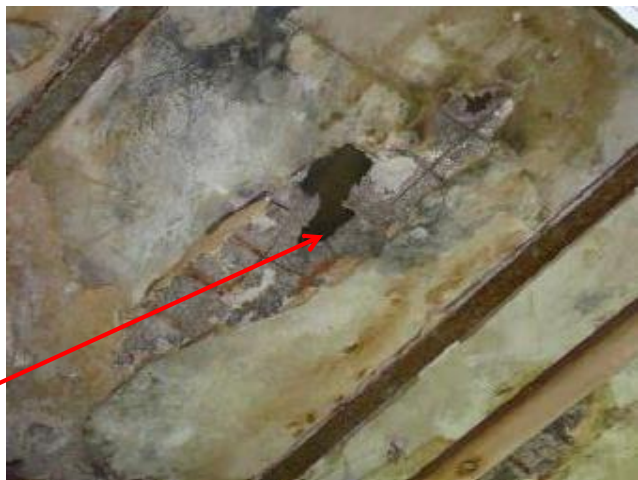
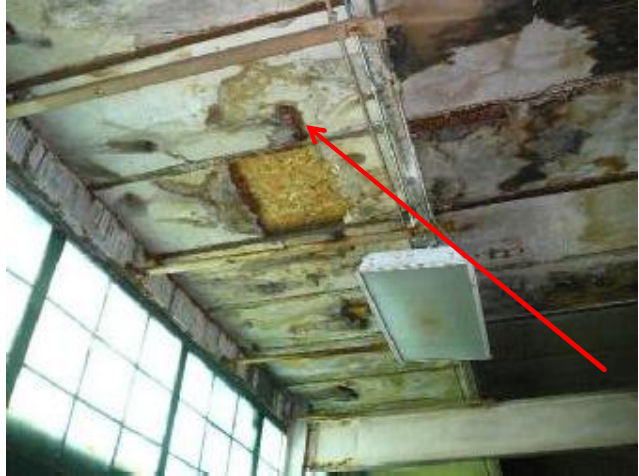
23

1) The south lower roofing is literally collapsing into the interior. The roof sheathing panels are a composite of reinforced cement with an interior finish plaster finish. The panels are completely saturated from roof leaks over huge areas, and are collapsing. Large areas have completely deteriorated and fallen apart; there is no reinforcing mesh remaining to hold them together.

This is both a roof issue and a life safety issue. These panels could collapse catastrophically. It cannot be ignored. This roof needs to be replaced.

Holed through and collapsed roofing panel close up.  
The steel reinforcing mesh is almost completely gone.  
The panels are collapsing.

The roof is leaking profusely. It should be totally torn off and replaced. This will mean complete, or nearly complete replacement of the old concrete panels with a new sheathing or roof substrate.

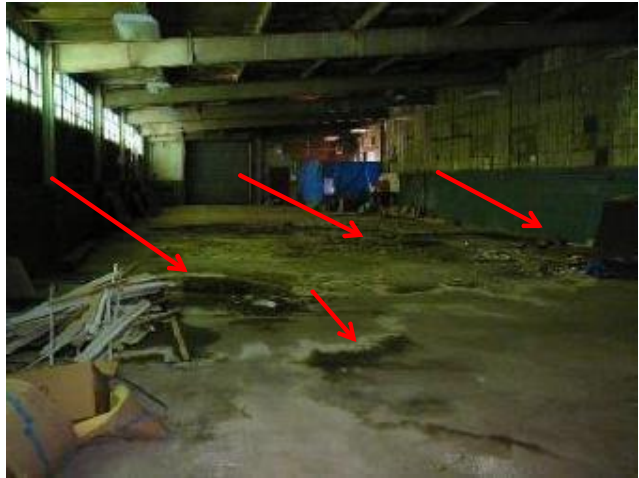
25

Water on the floor of the south building from massive roof leaks.

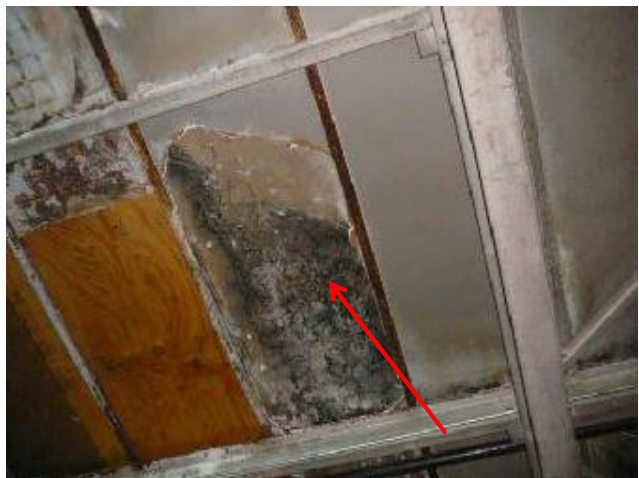
26

Moldy and deteriorated roof panel.

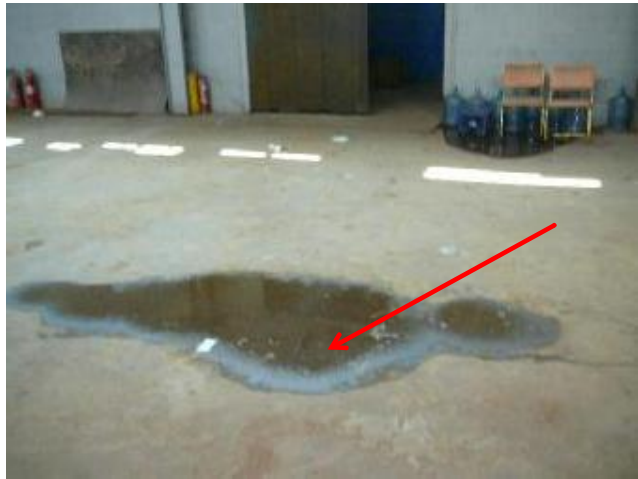
27

4) The north middle roof apparently leaks. There were water ponds on the floor of the middle building at the inspection. I can imagine several areas where it could be leaking. At minimum, it needs a major amount of patching to stop the current leaks.

Water at the interior of the middle building. The main central roof leaks.

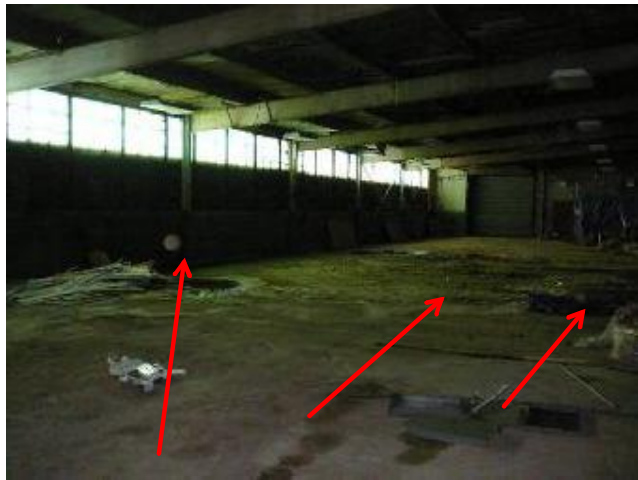
28

More water on the floor of the southern building.

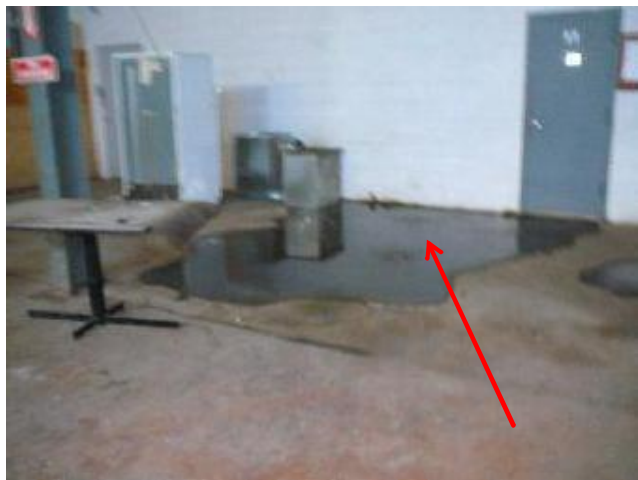
29

More water at the interior wall of the middle/central warehouse.

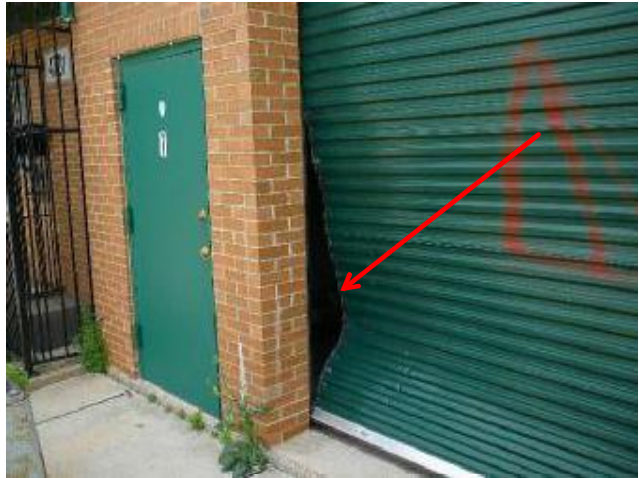
31

5) The north wall east garage door has been smashed in. The door will need to be replaced.

North wall east garage overhead door is smashed off its track.

Repair or replace the door.

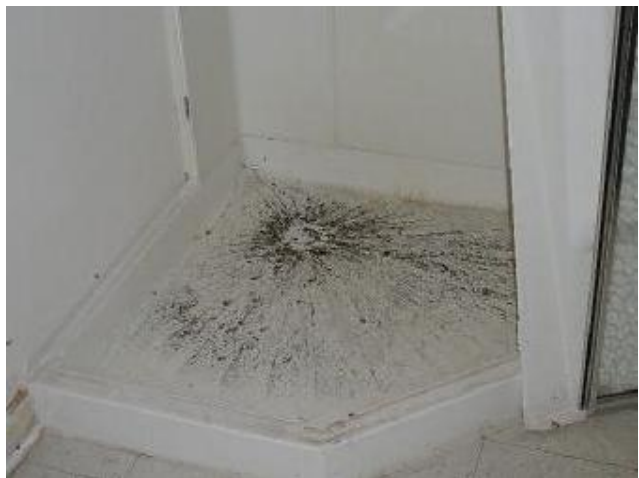
32

The sewer apparently backed up through this shower.

There is no ejector system or anti-backflow device in the building sewer or drain system. Until such anti-backflow devices are installed, you could have recurring backup problems from the City sewers during heavy rains or flooding conditions.

There is no ejector system or anti-backflow device in the building sewer or drain system. Until such anti-backflow devices are installed, you could have recurring backup problems from the City sewers during heavy rains or flooding conditions. You should install an anti-backflow device in the building sewer.

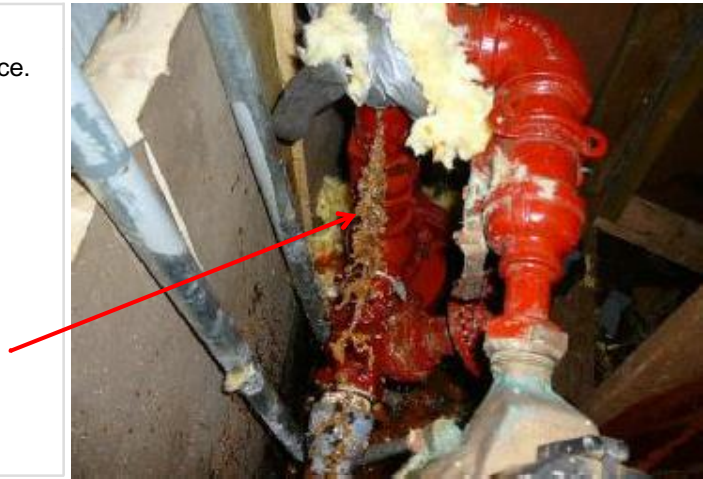
33

2) The main water service entrance is fractured from a freeze during the winter. When I opened the main valve slightly, water spewed out of several locations. I shut the water back off. The main water supply entrance meter components need replacement.

Burst water main at the main water service entrance.  
Water is spewing out of the fractured pipe.

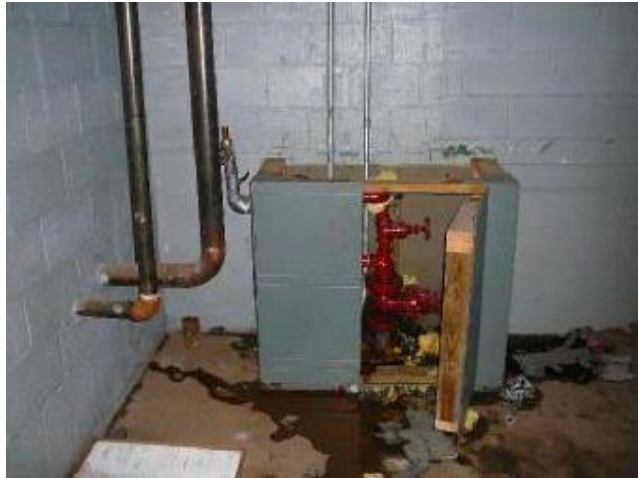
34

Pull back shot of water entrance cabinet.  
The cabinet cannot provide any resistance to freezing without a heat source. There was no heat source, so the pipe froze.

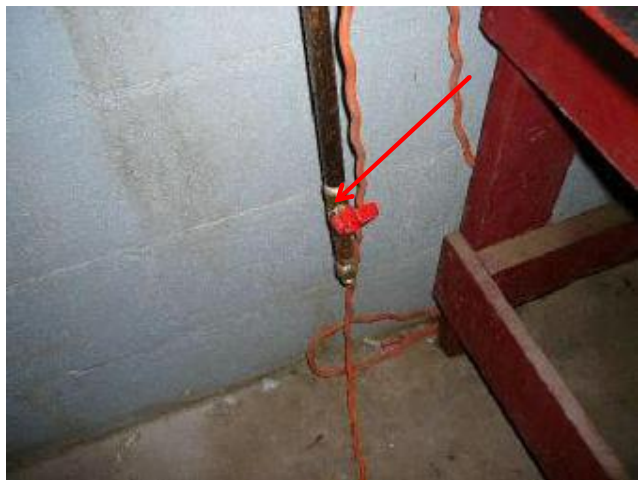
35

A very significant major concern is the gas service to the building is still active. When the thieves stripped out the equipment, they did not take the time to cap the gas lines. If anyone turns any gas appliance valve on accidentally, the interior could fill up with gas and explode. The gas service to the building should be cut off at the meter immediately. Have a contractor or the gas company shut off the gas service.

Open gas line at location of old furnace.  
If this valve were opened, the building would fill with gas.  
All the gas lines should be capped immediately.

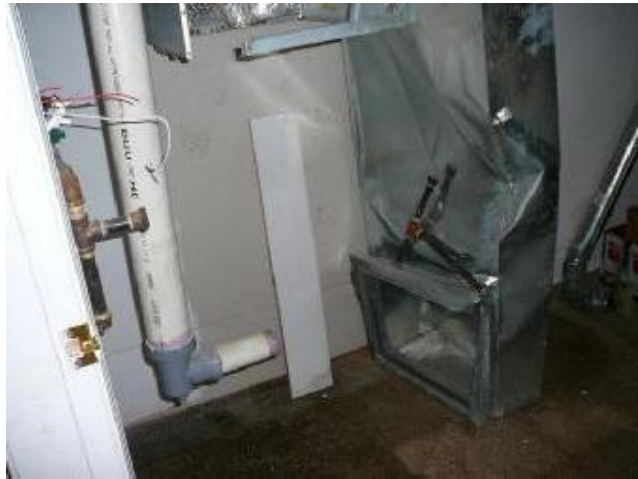
36  
Smashed furnace installation area.

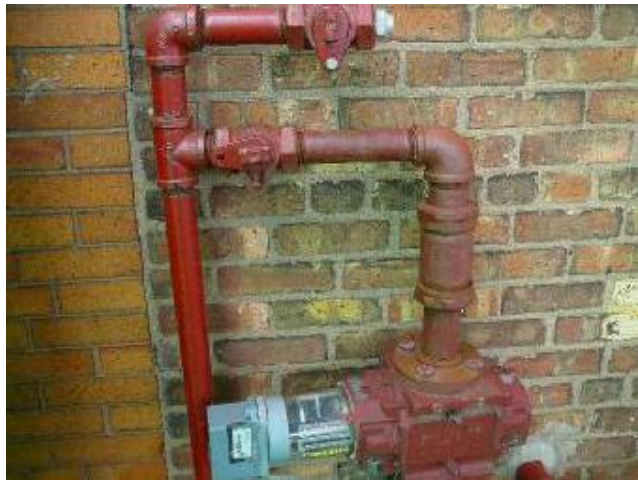
37  
The gas meter at the NW corner of the building is still on.

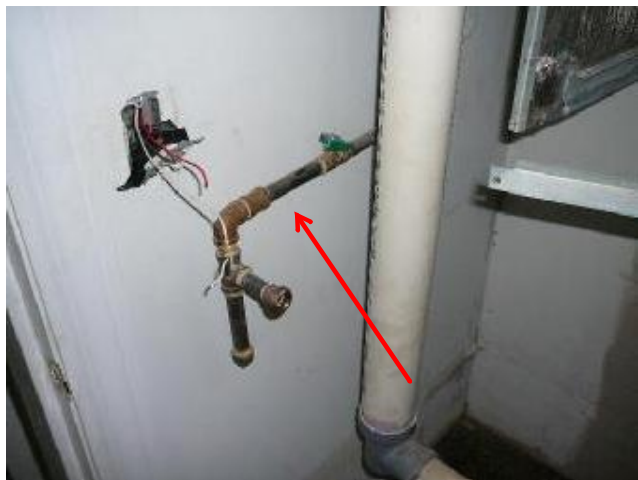
38  
Open gas line.

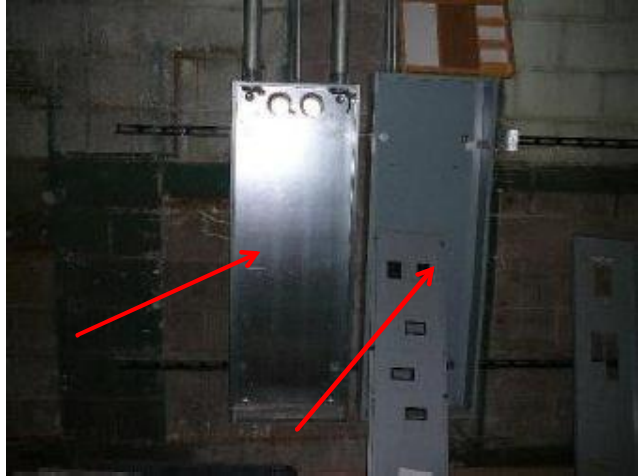
39

Stripped out electrical service equipment.

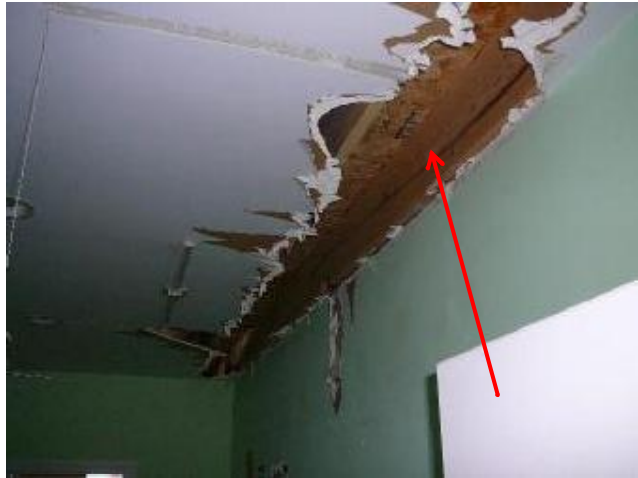
40

2) The office space has been essentially stripped of useful fixtures. The drywall is trashed from the plumbing having been stripped. The office space has to be cleaned out and refurbished with new fixtures, bathrooms, and finishes.

Stripping out plumbing caused this damage to the drywall finishes.

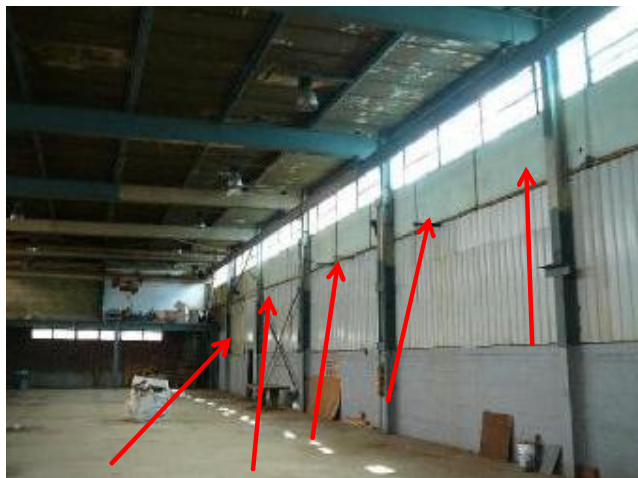
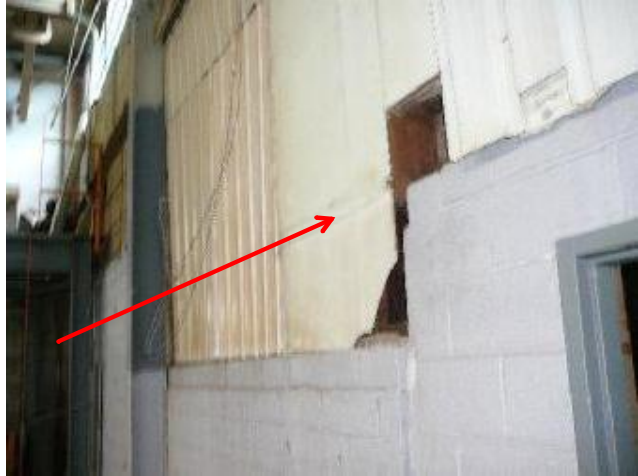
41

1) There are white panels along the south wall of the middle main warehouse area that look like they could contain asbestos. You should have these panels tested for asbestos content by a licensed asbestos abatement contractor.

These panels may contain asbestos.

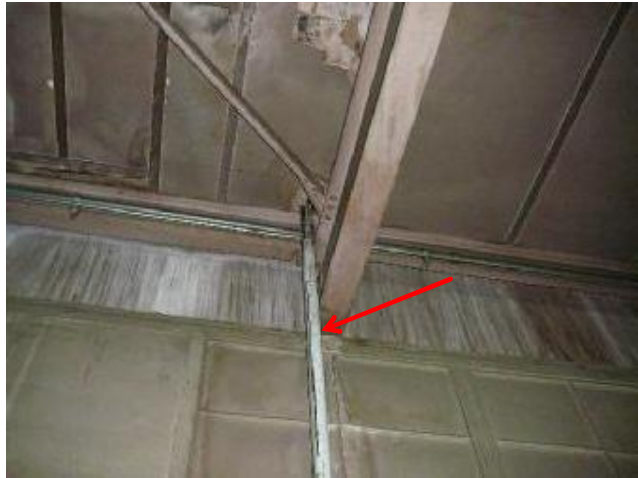
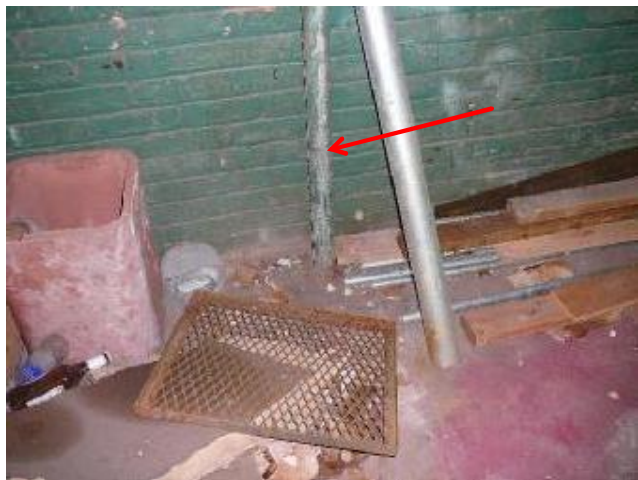
43

3) There is (what looks exactly like) an old buried fuel oil tank vent pipe running up the north wall of the southernmost building section. The pipe is on the south side of the wall from the main middle building. It is located approximately in the westerly third of the wall section. The pipe extends above the roofline at the middle building.

There may be a buried fuel oil tank on the property. Buried tanks on commercial properties are regulated by the EPA. If there is fuel oil leakage into the soil, the owner of the property can be responsible for very expensive soil decontamination costs. If any tanks were removed without required engineering and environmental overview, there can be punitive fines levied.

Suspected fuel oil tank vent pipe.

This same pipe extends down into the floor at the south building.

You need to know about buried fuel tanks on the property. Review the concern with the seller. You should also have a tank location and removal contractor look at the property and provide a report regarding presence or absence of buried fuel tanks and soil contamination.

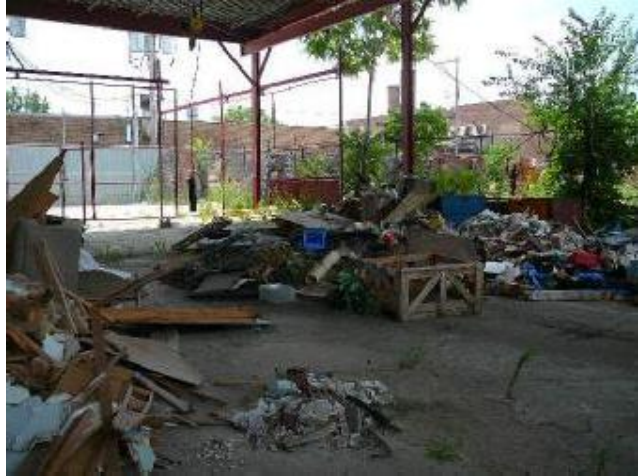
48

- 1) The west loading area was completely filled with garbage and junk. It should all be cleared out.
- 2) There is still inventory from the previous tenant in the west storage yard. There are several pallets of bricks and masonry still on site. Remove all the previous tenants inventory.

Garbage at the west loading area.
