Kurt Mitenbuler & Associates, Inc.

Property Inspection location:

Inspection Date Monday, October 1, 2007

Photolog of Major Concerns

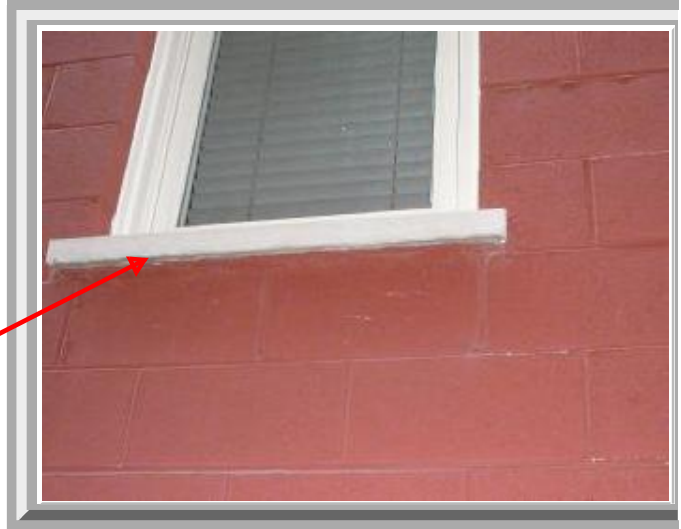
3
No flashing under the windows.....

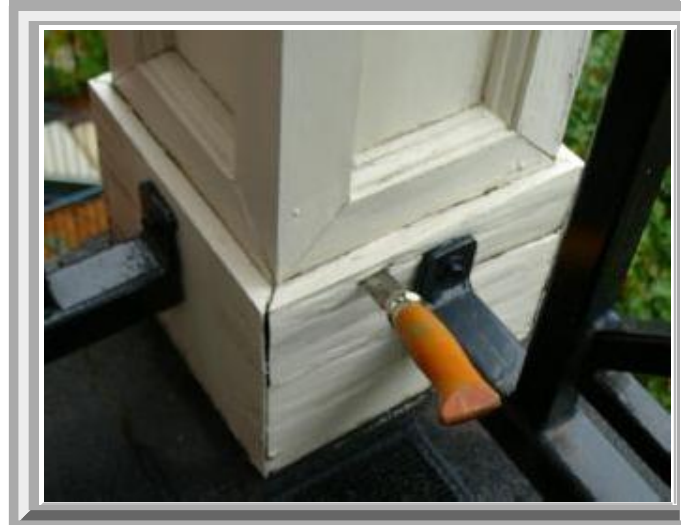
28

Base of posts is also totally rotten.

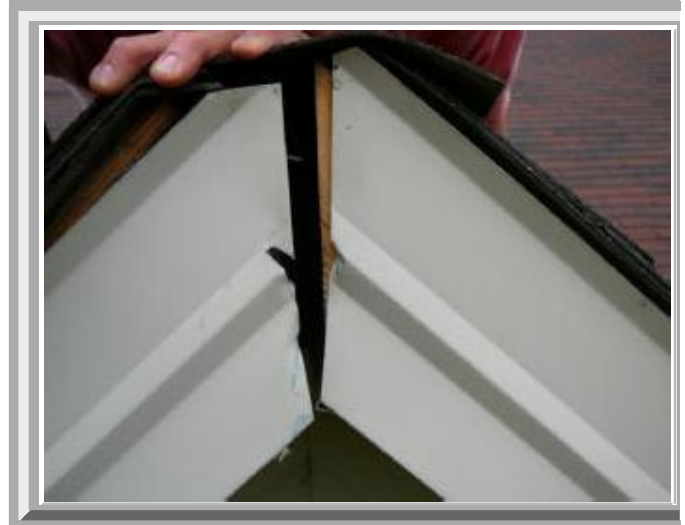
49

Another shot of same; they are gapped almost 1".

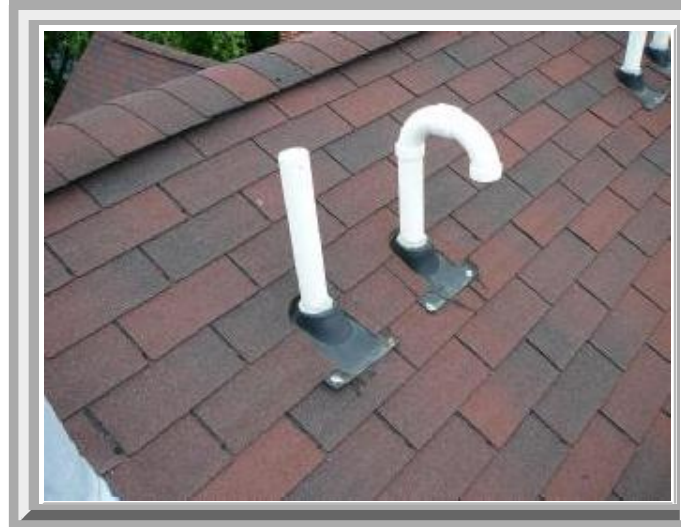
51

Roof discharge combustion gas vents from heating equipment.

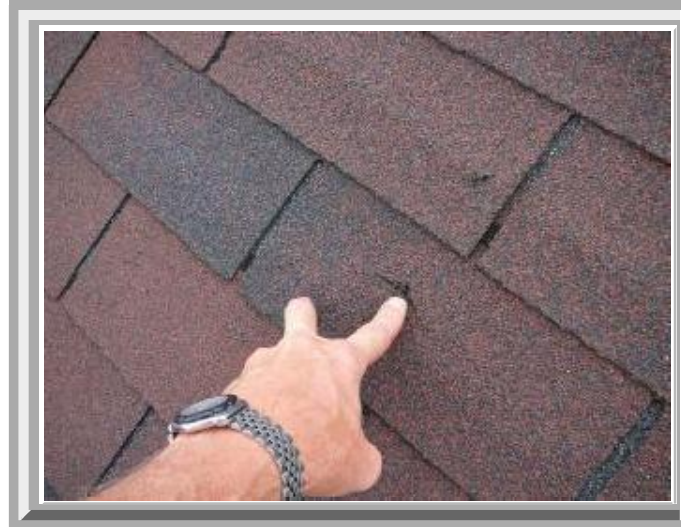
54

Another shingle holed through.

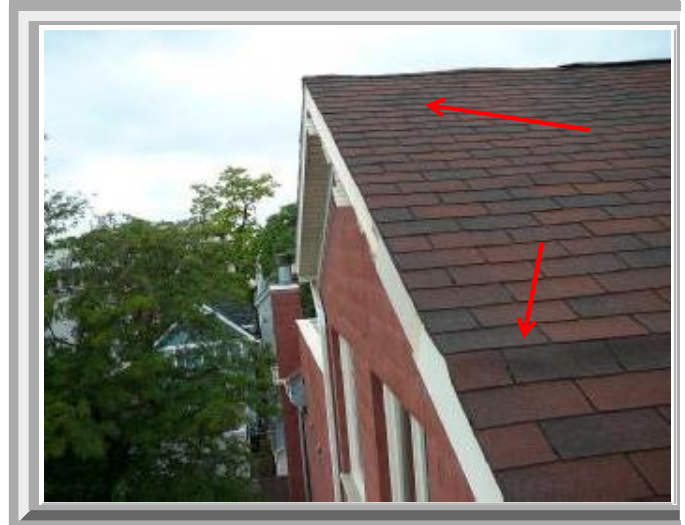
55

More ridges in the roof sheathing.

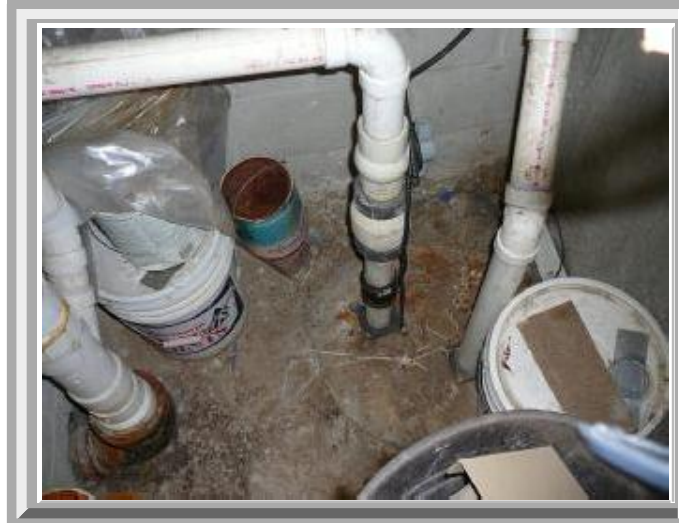
73

Ejector system @ the rear mechanical room.

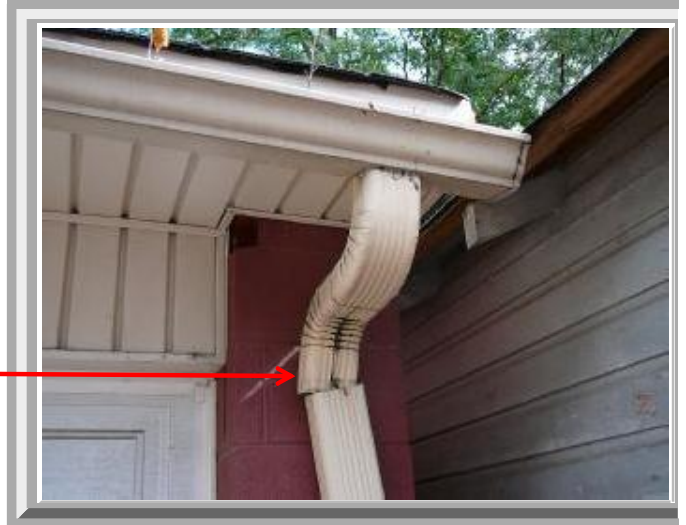
76

Disconnected downspout @ the garage.
